CLEARWOOD COMMUNITY
BRIDGE & DOCK INSPECTION REPORTS
FOR
CLEARWOOD COMMUNITY ASSOCIATION
PROJECT #2020-0272

MC SQUARED, INC.

08 / 24 / 20

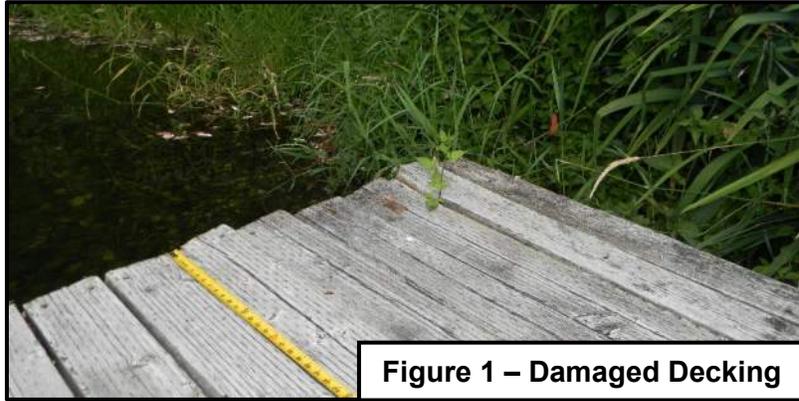
The pressure-treated framing is not experiencing significant rot or water damage, but up to 1/2" knife penetration was observed at some rim joist locations. This amount of penetration suggests that they may need to be replaced in the near future. Timber decking is experiencing surface weathering and is warped and lifting at some edges. The primary decking damage is located at the 20' by 14' section and is in need of replacement at the northern dock (Figure 1).

Figure 1 – Damaged Decking

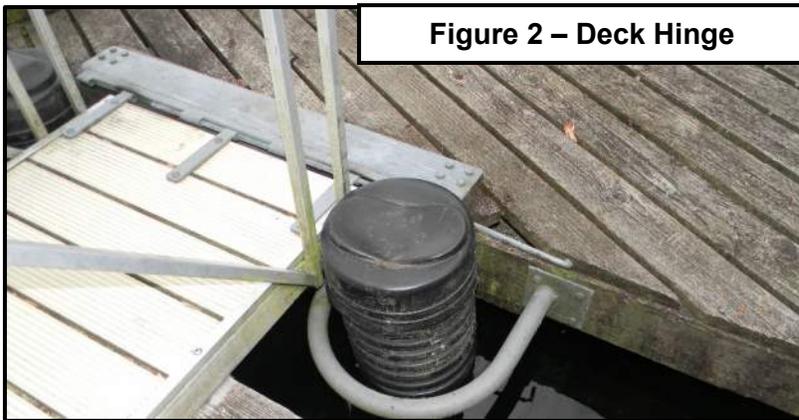
An aluminum ramp is located between the 20' and 14' platform and the angled section which is holding the two ends of the docks together using a 4' wide hinge. The pin in the hinge is damaged and should be replaced (Figure 2). The concrete slabs at the shore sides of both docks are both undermined. The slab at the south dock is undermined up to 9" in both directions at the shore side and must be filled in (Figure 3). The slab at the north end is undermined beneath the middle and is spanning about 1' and will break eventually if not filled in and supported (Figure 4).

Figure 2 – Deck Hinge

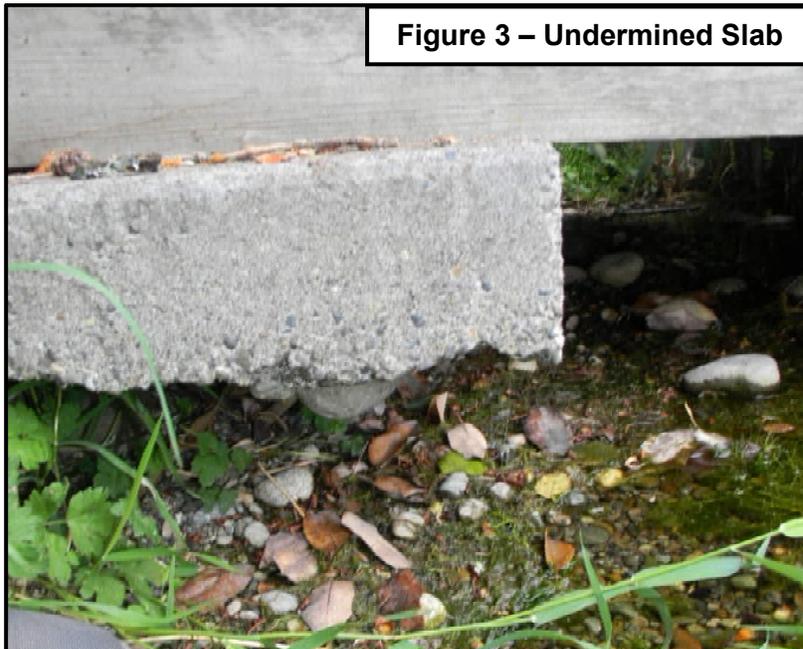
Figure 3 – Undermined Slab

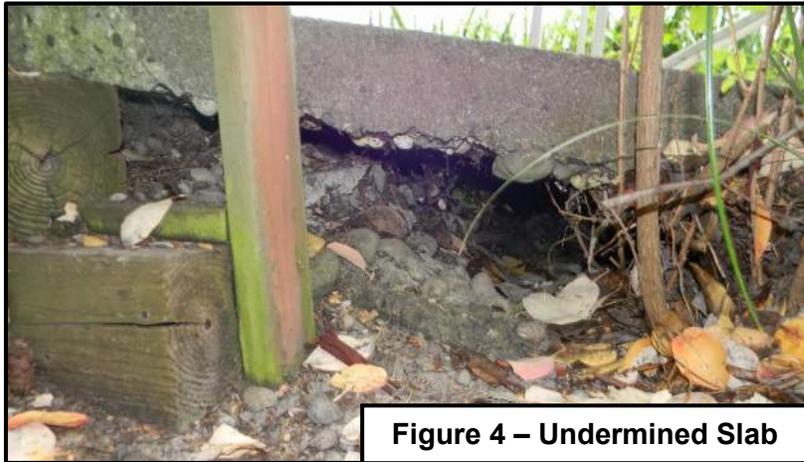
Figure 4 – Undermined Slab

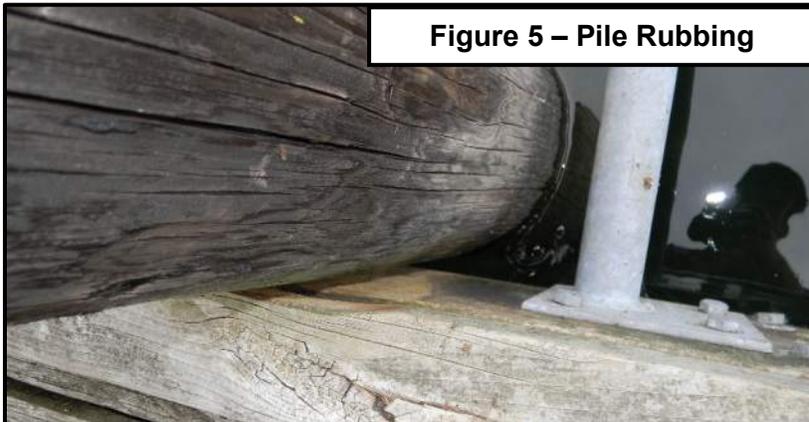
The pile at the northeastern corner of the south dock is rubbing against and wearing away a 16" section of the end rim joist and may be a concern in the future (Figure 5). At the end of the north dock, the end tire supports is completely submerged under water with the weight of two people at the end of the dock. The tire floats may need to be replaced to provide sufficient support.

Figure 5 – Pile Rubbing

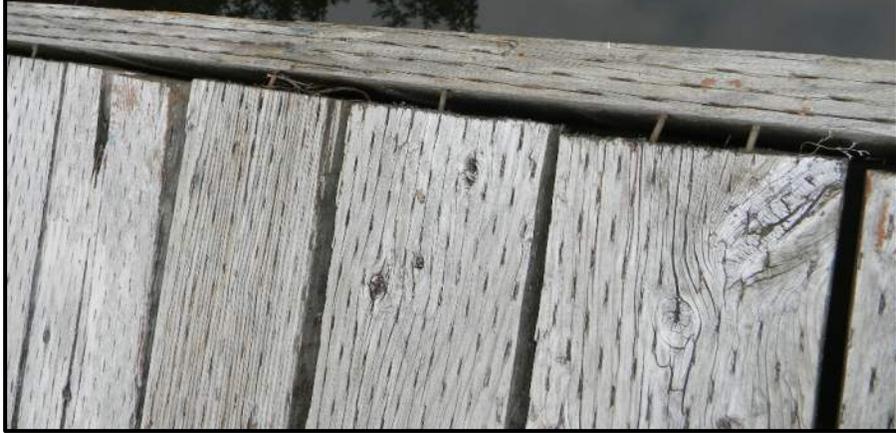
The rim joists are warping around the perimeter and are separating from the decking, causing nails to be exposed (Figure 6). The decking displays significant sagging and rot, which will require replacement throughout. Additional stringers are suggested to reduce this problem in the future.

Figure 6 – Decking Separation

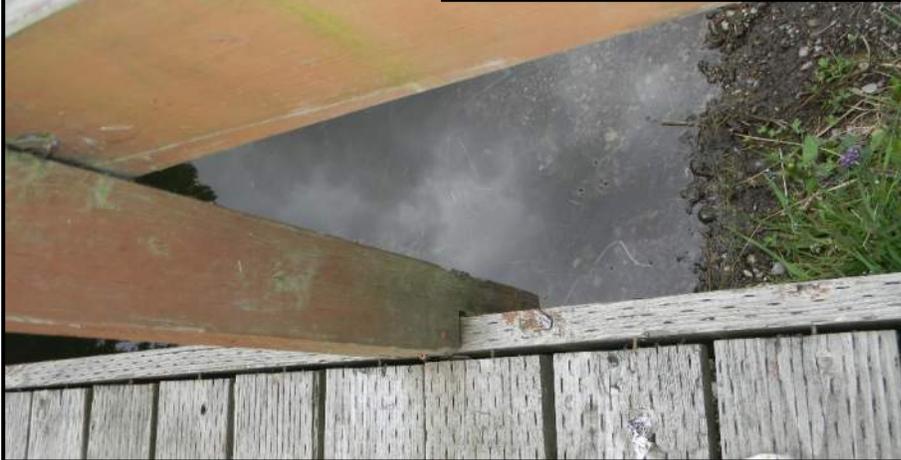
All guard rail posts have been notched at the base and visibly sag outward (Figure 7). The posts are also easily moved by hand. Many of the handrail sections are significantly damaged as well. The guard rails must be replaced with 4x4 or 4x6 posts without notching the bottoms and the handrails should be replaced as well.

Figure 7 – Notched Posts

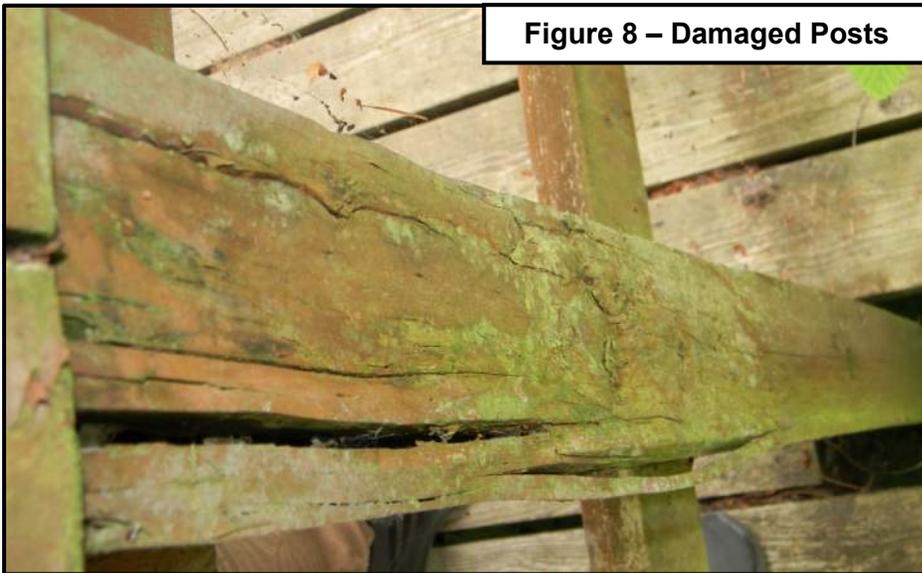
The guard rail posts are fully intact at the base and are attached to the exterior stringers with two 1/2" diameter bolts, spaced 6" apart. The posts are spaced at 6' on center and are deflecting when pushed on. Some of the guard rail posts are splitting or showing rot and should be replaced (Figure 8).

Figure 8 – Damaged Posts

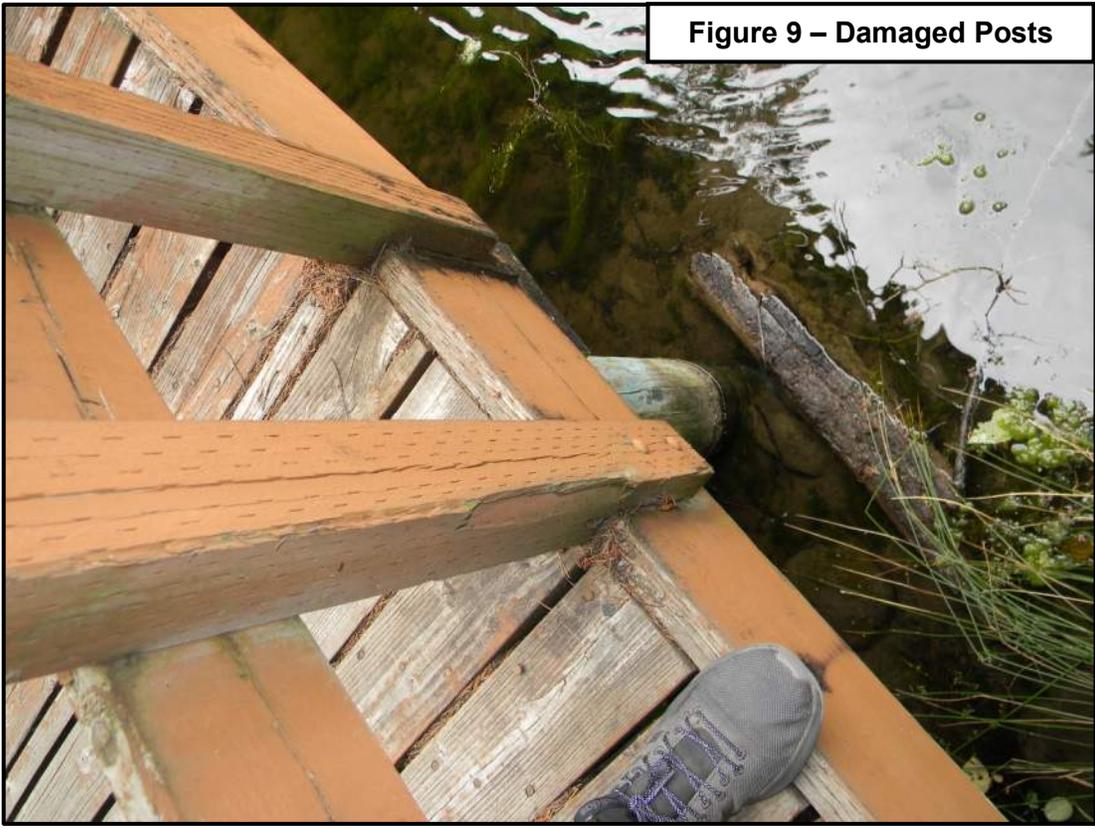
All guard rail posts are attached to the rim joist/fascia, have been notched at the base, and are visibly sagging outward (Figure 9). The posts are also easily moved by hand. Many of the handrail sections are significantly damaged as well. The guard rails must be replaced with 4x6 or 4x4 posts without notching the bottoms of the posts and the handrails should be replaced.

Figure 9 – Damaged Posts

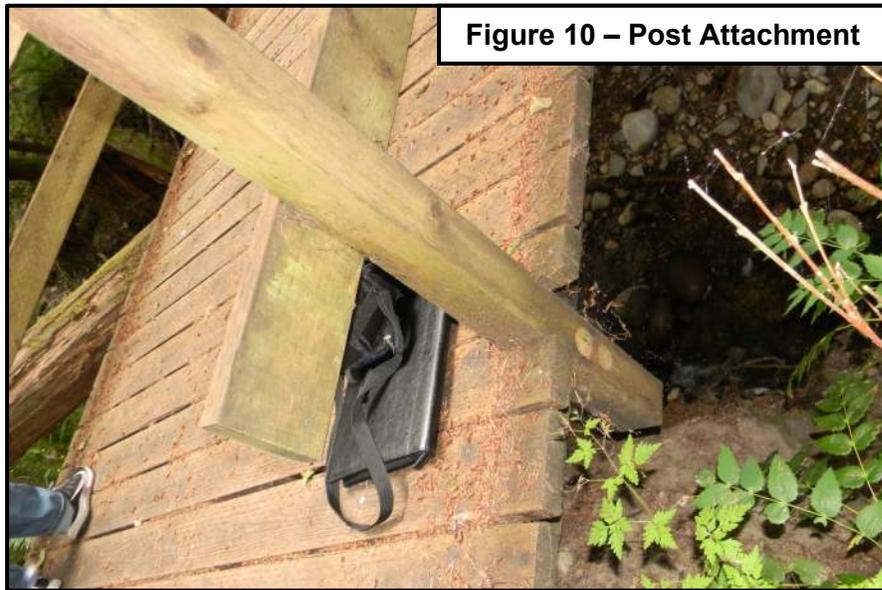
The guard rail posts are notched at the base and are attached to the exterior stringers with two ½" diameter bolts, which are spaced 2" apart (Figure 10). The posts are spaced at 7' on center and visibly deflect when pushed on.

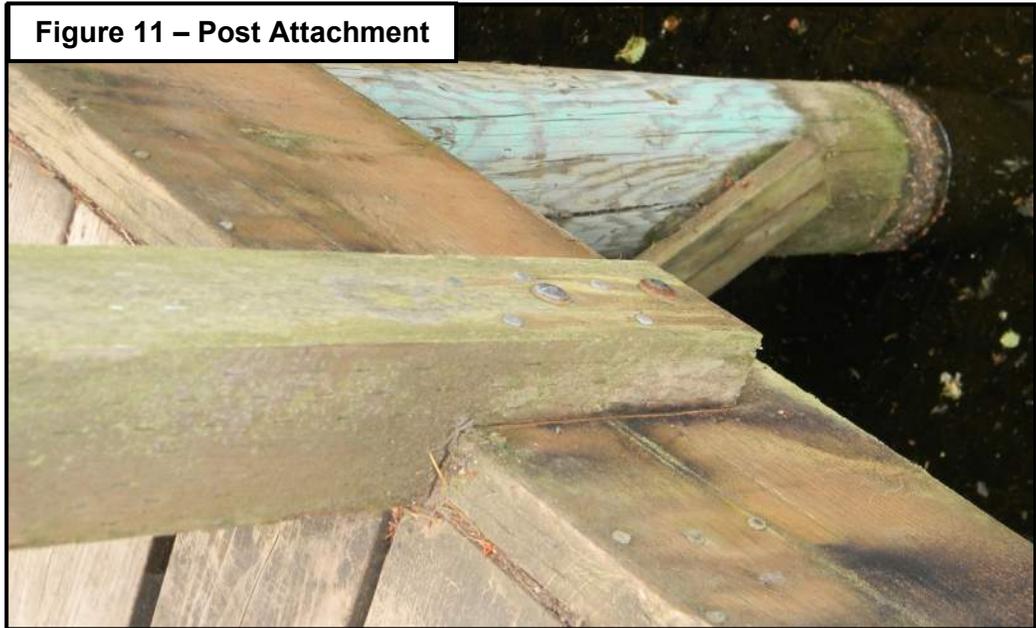
The guard rail posts are notched at the base and is attached to the rim joists with multiple nails and two 1/2" diameter bolts, spaced 6" apart (Figure 11). The bays beside the posts have 4x blocking between the rim joist and stringers. The posts are spaced at 4' on center and slightly deflect when pushed on. The guard rail post spacing meets code requirements, but the notched 4x4's do not and replacement would be recommended.

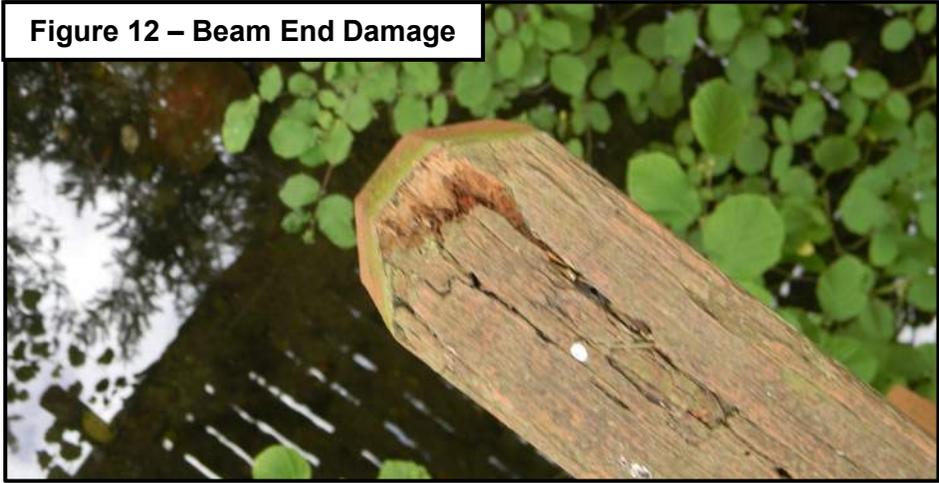
The steel channels are to be free of rust and the exterior paint coat is undamaged. The 4x8 beams supporting the stringers are also supporting the guard rails at their ends and extend out up to 2' at some locations. The extended ends are deteriorated at some locations and should be cut off and sealed with a cap (Figure 12).

Figure 12 - Beam End Damage
