Clearwood Community Association
Yelm, WA

Project #: 10182000091

**Site Evaluation and Recommendation Report
For CCA Tennis Courts**

**1/29/2021
(revised 2/19/2021)**

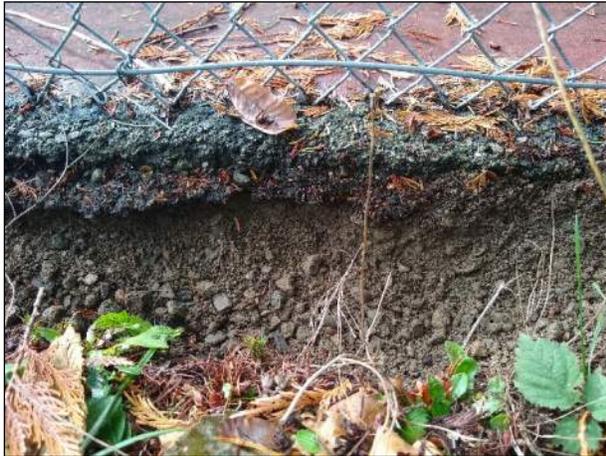
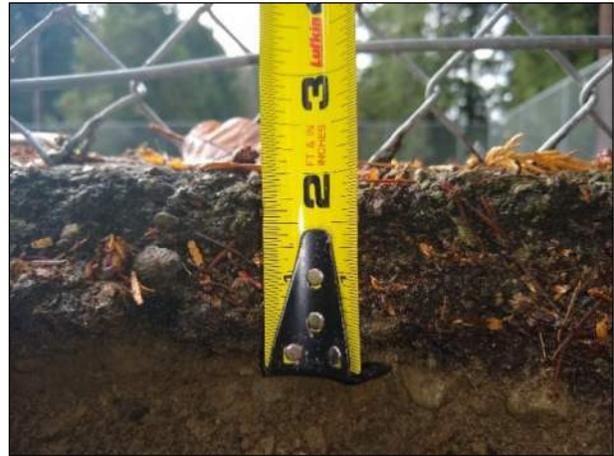
FIGURE 2: TYPICAL PAVEMENT SECTION PHOTOS

Non-destructive excavation at the edges of the courts indicates that the court pavement sections are made up of approximately 2 inches of hot mix asphalt pavement above 2 inches of crushed surfacing gravel.

The surface condition at each of the 3 tennis courts would have greater longevity with the utilization of a more substantial pavement section. The current pavement section of approximately 2 inches of asphalt with 2 inches of crushed surfacing is on the lighter side for this type of improvement. If replacement of the courts is desired a thicker pavement section should be utilized.

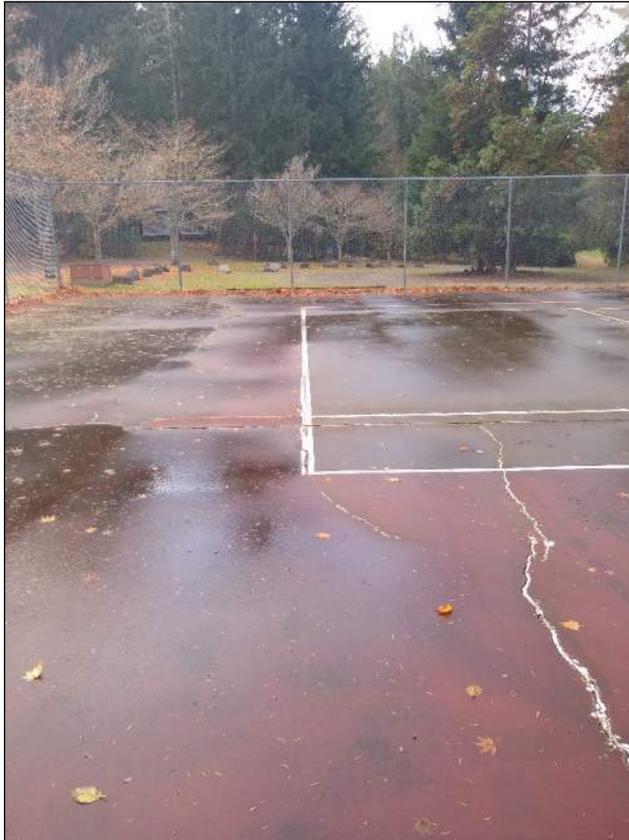
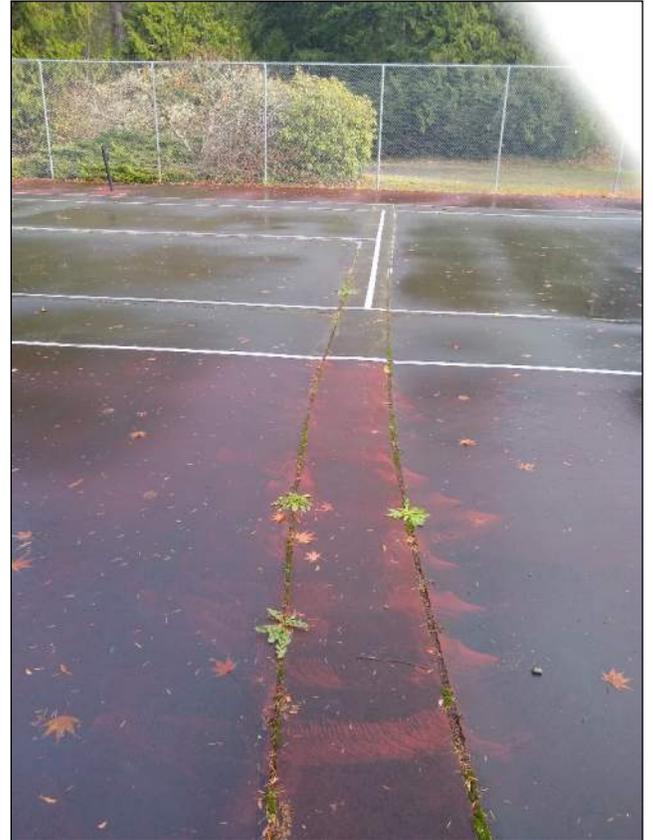
FIGURE 3: LONGMIRE PHOTOS

The Longmire tennis court was the only court that had an acrylic top layer. Cracking is prevalent throughout this tennis court and areas of previous block repairs transect the court. Moss, grass, and weeds have taken root inside cracks and failed joints to compound issues. Tennis net posts have pavement upheaval and are leaning toward the center with of the court most likely due to inadequate post foundations and continuous tension of the wire used to support the net pulling the posts inwards.

The existing soils beneath the Longmire tennis court have been previously recorded as peat soils. The northernmost corner of the tennis court is also adjacent to the top of a slope that leads to a stream. Soft soils and sloughing of the slope were observed.

The suspected peat soils underlying the Longmire court present potential issues with differential settlement for both the current pavement and future improvements. While the loading on a tennis court is low there is still potential for settlement due to changing hydrologic conditions in the soil. The proximity of the court to the stream slope also imposes increased risk for settlement at this location.

A pavement overlay for this court would not be a good option as the existing pavement section is not substantial enough to resist settlement cracking. Surface cracking and localized settlement would eventually migrate through a new asphalt overlay.

Removal and replacement of the pavement section is an option that can be considered. If replacement is selected for this location, then we recommend removal of the existing pavement completely and over-excavating the native subgrade. After excavating the native subgrade then imported structural fill or crushed rock should be placed to provide a more substantial base course for pavement.

Performing minor repairs at the Longmire court may include crack sealing, minor reapplication of acrylic court surfacing, and minor grading. These minor repairs would cost approximately \$5,000 to \$10,000.

A total overhaul option for Longmire includes full demolition of the existing court surface, over-excavation to account for subgrade failures, subgrade replacement, a new asphalt surface, replaced net posts, and a new acrylic top layer. The total overhaul construction cost estimate ranges from approximately \$60,000 - \$80,000. Engineering and construction site inspection services can be estimated at an additional \$8,000.

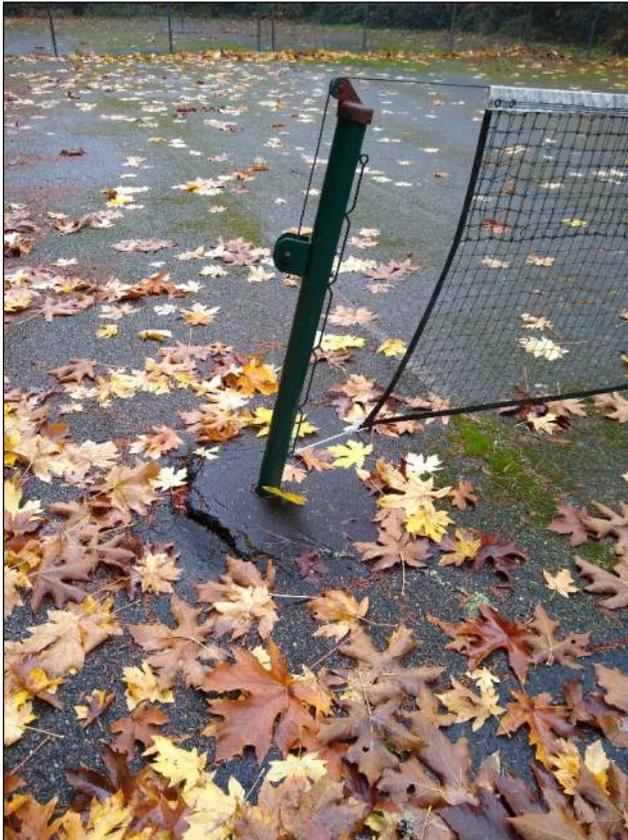
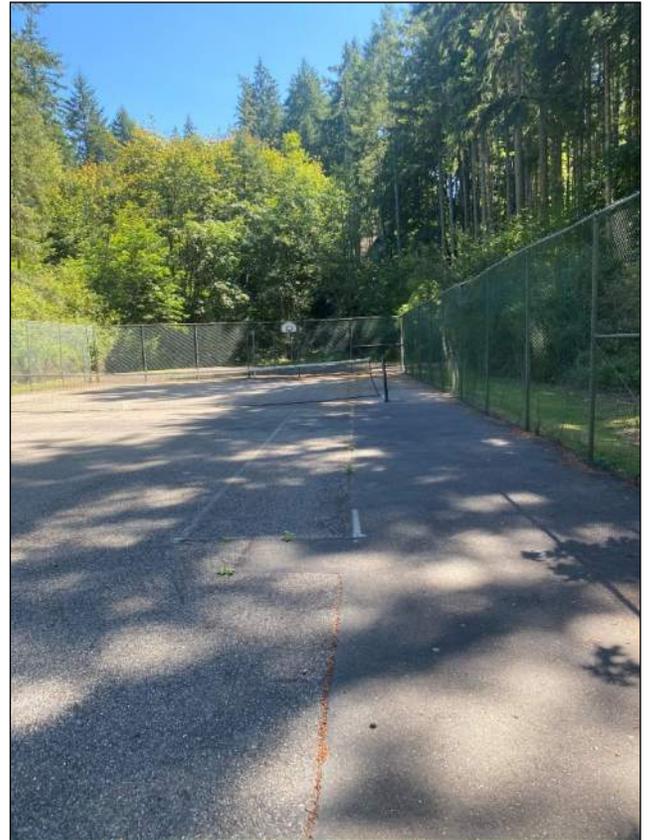
FIGURE 4: HI-LO PHOTOS

The Hi-Lo tennis court surface is asphalt without a topcoat layer. Large areas of the court had been patched in recent years and transverse cracking was observed. Areas of settlement were also observed consistent with subgrade failure. Both tennis net posts have pavement upheaval and are leaning toward the center with of the court most likely due to inadequate post foundations and continuous tension of the wire used to support the net pulling the posts inwards.

The Hi-Lo court is in a valley, with surrounding terrain at significantly higher elevation than the court itself. Stormwater from the surrounding area naturally flows towards the low point where the tennis court is located. The park area is in a localized low point with no observable stormwater discharge other than infiltration.

Site drainage is a significant concern for the longevity of future improvements at the Hi-Lo tennis court. This court is in a natural low point for the area with slopes on all sides. No surface water outlet was observed at the site and it appears that runoff directed to this low point infiltrates in the vicinity of the tennis court and beyond the basketball court pavement.

Drainage improvements should be considered as an integral part of future improvements of the court at this location. Directing stormwater away from the courts as much as possible with swales or french drains would reduce the likelihood of saturating the pavement base course.

A pavement overlay is not recommended due to the amount of cracking and pavement distress. Pulverizing in-place and recompacting the existing pavement and subgrade prior to installing a new pavement layer with additional base course is an option that may be more cost effective than a full replacement.

Performing minor repairs at the Hi-Lo court may include crack sealing, minor asphalt patching, and excavation and regrading of drainage swales in the area surrounding the court to mitigate existing drainage issues. The minor estimate ranges from approximately \$10,000 - \$16,000.

A total overhaul option for Hi-Lo includes full demolition of the existing court surface, over-excavation to account for subgrade failures, subgrade replacement, a new asphalt surface, replaced net posts and footings, and regrading and excavation with the installation of

approximately 300 feet of french drain to intercept storm runoff and improve drainage conditions. The total overhaul estimate ranges from approximately \$70,000 - \$90,000. Engineering and construction site inspection services can be estimated at an additional \$8,000.

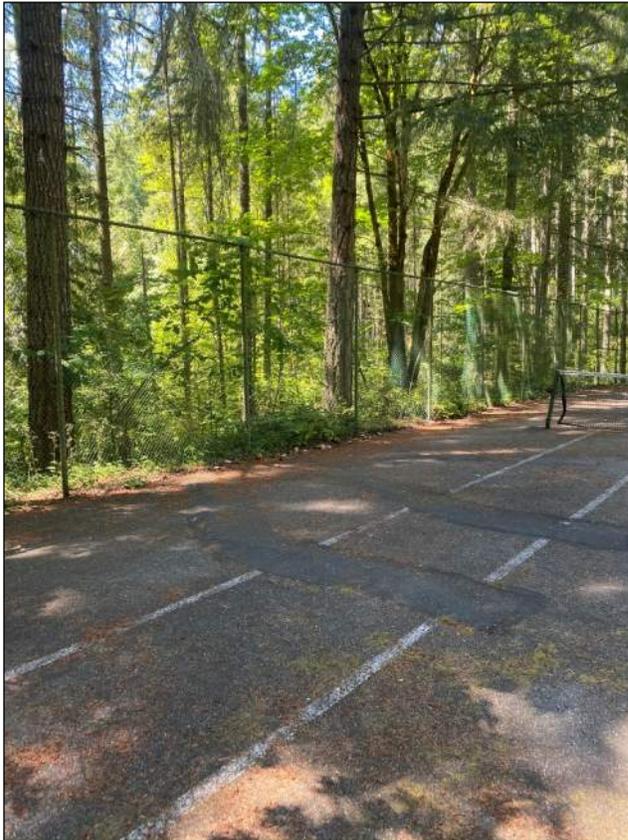
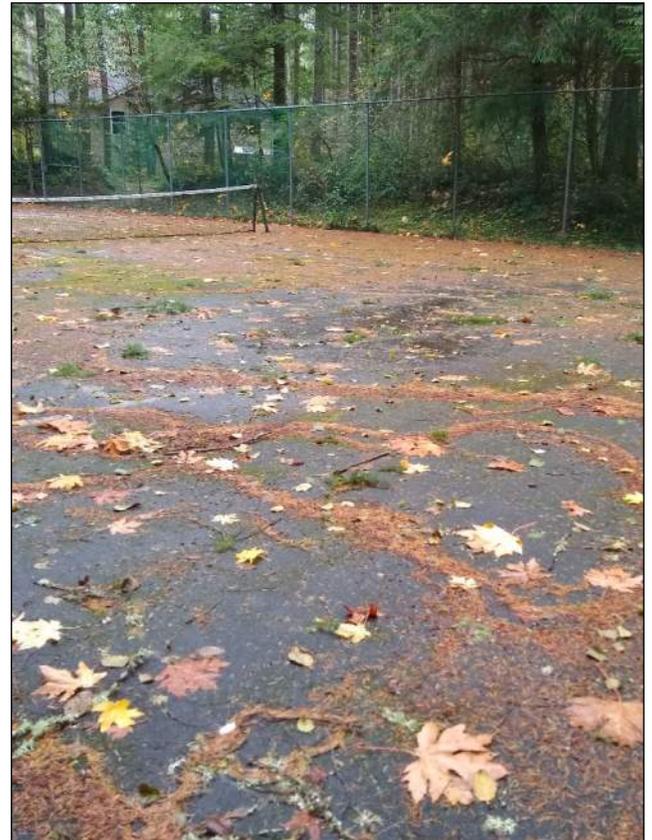
FIGURE 5: RAMPART PICTURES

The Rampart tennis court surface is asphalt without a topcoat layer. Poor surface drainage conditions exist at the Rampart court, with observable ponding on the court surface.

Pavement settling due to inadequate subgrade likely contributed to the depressions throughout the pavement surface. Many large trees are in close proximity to the court and tree root upheaval has damaged pavement around the edges of the court surface and accumulation of leaves and fir needles. Both tennis net posts have pavement upheaval and are leaning toward the center with of the court most likely due to inadequate post foundations and continuous tension of the wire used to support the net pulling the posts inwards.

While some subgrade failure was observed, tree root upheaval was the primary cause of pavement failure at the Rampart court. Removal of trees near the court is recommended if this site is improved in the future. This will remove the root upheaval problem and allow for improvement to grades near the court.

There is a lot of topographic relief in the vicinity of the court with some areas draining toward the court and some sloping away. Re-grading slopes adjacent to the court to direct water away from the pavement is also recommended as part of any future improvement.

Pulverizing the existing asphalt layer in-place and recompact the existing pavement and subgrade prior to installing a new pavement layer with additional base course is also an option for this court.

Performing minor repairs at the Rampart court could include crack sealing, minor asphalt patching, and the removal of 4 trees nearest the court to prevent further root upheaval of the repaired court surface. The minor estimate ranges from approximately \$9,000 - \$15,000.

A total overhaul option for Rampart includes full demolition of the existing court surface, over-excavation to account for subgrade failures and root upheaval, subgrade replacement, a new asphalt surface, replaced net posts and footings, replaced chain link fence, and the removal of 10 trees nearest the court surface. The total overhaul estimate ranges from approximately \$60,000 - \$80,000. Engineering and construction site inspection services can be estimated at an additional \$8,000.
