January 15, 2021

RE: Structural Examination at Clearwood Community Pool in Yelm, WA

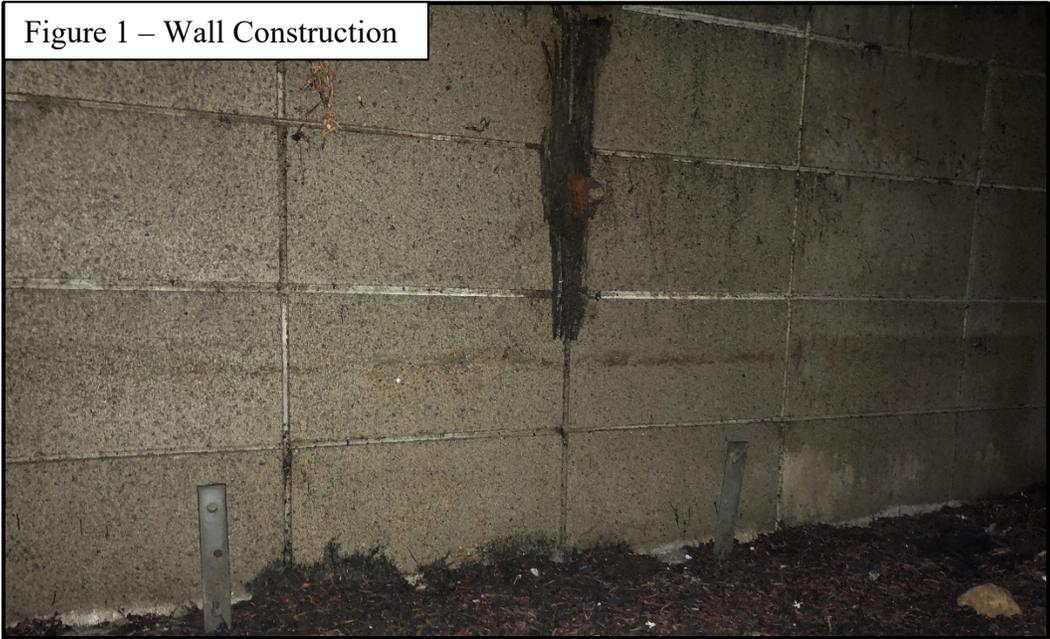
The CMU retaining wall has been constructed of standard 16"x8"x8" nominal concrete masonry units which have not been staggered (not laid in running bond) or reinforced (See Figure 1). The joints have been grouted, but the cells are not grouted. This construction is not allowed for structural design, however given that it is not taller than 4', engineering was not likely required at the time of construction. 1/2" diameter bolts had been installed in the face of the CMU wall to support guard rails which have been cut off at the top of the wall in the early 2000's as I have been informed by Ryan (See Figure 2). Some time ago multiple horizontal cracks appeared in the top layer of the wall, at the same height as the guard rail post anchor bolts. The longest crack is up to 11' in length (See Figure 3) which is located towards the middle length of the wall.

The cracks in the wall are most likely due to a combination of age, insufficient design, and the post-installed guard rail post anchor bolts. The wall was constructed in the 80's along with the rest of the pool and is not protected from weathering. The wall was also likely been improperly constructed. While the orientation of the blocks is allowed, the way in which the wall should have been constructed would require reinforcement and cell grouting around the reinforcement. Standard construction around this time would likely not allow the CMU retaining wall to be built like this. The installation of the anchor bolts into the face of the wall created weak points. These weak points are most likely the source of the cracks at the top of the CMU retaining wall.

Filling the cracks in the wall with an epoxy may serve as a temporary repair, but there is no permanent repair which would suffice. The cracks in the CMU retaining wall should be epoxied, but replacement along with additional soil compaction is the only permanent solution.

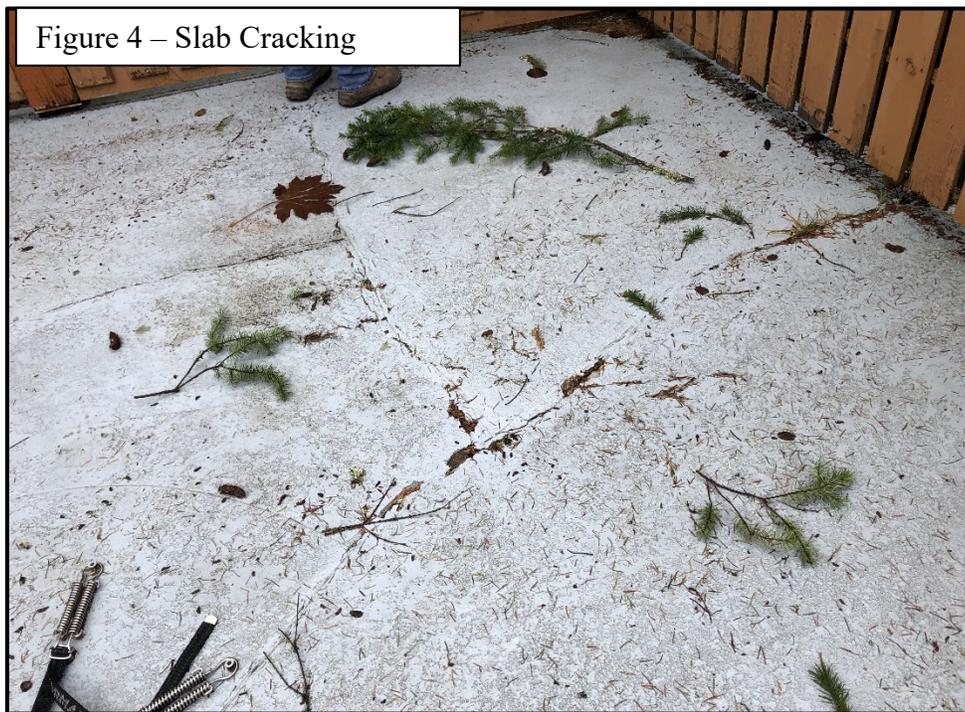
The concrete slab is cracked on all sides surrounding the pool and shows signs of settlement. The westernmost corner of the slab is cracked which has caused it to separate from the rest of the slab and is now starting to slope downhill (See Figure 4). You've informed me that the rim of the pool and the slab used to be level, however there is now up to an approximate 3/4" difference in elevation. The slab is also slightly sloping downhill throughout.

The slab damage is due to settlement. The pool area was built on soil fill, which was likely not properly compacted and has settled. Other possible causes of the settlement could be from a consistent source of pool water and rainwater in the area, which could have easily leaked through the cracks in the slab and created additional voids below. The slab settlement issues have more than likely caused by a combination of uncompacted fill and improper drainage, which caused the depressions and cracks in the slab.

The CMU retaining wall will eventually need to be replaced. However, the current damages to the wall and slab at this point in time are no more than a tripping hazard. Repairing the slab would likely be more costly than replacing the slab, and the wall cannot be fully repaired.
