## Update "With-Site-Visit" Reserve Study

### Clearwood HOA Yelm, WA

**Report #: 7223-5**  
**For Period Beginning: January 1, 2019**  
**Expires: December 31, 2019**

**Date Prepared: April 19, 2018**

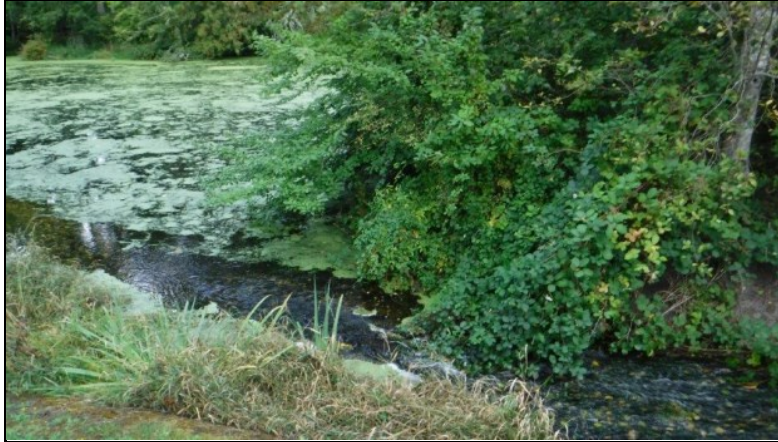
Evaluation: We did not observe this area during our September 2017 site visit, however no problems reported to us. Periodic large scale funding factored for repair / replace.

Useful Life:  
40 yearsRemaining Life:  
6 years

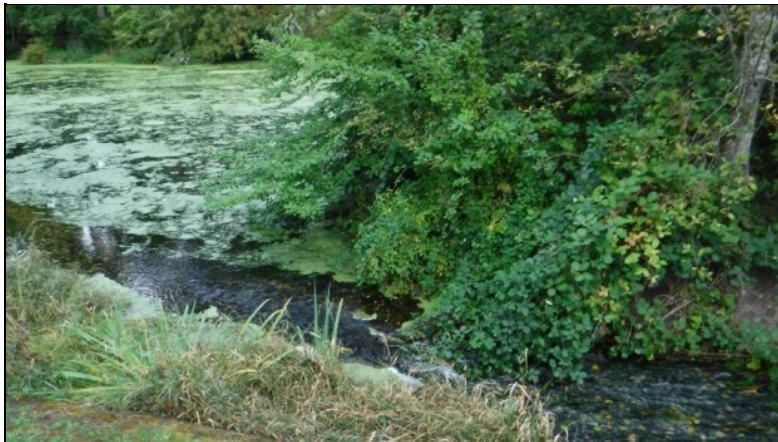
Evaluation: We did not observe this area during our September 2017 site visit, however no problems reported to us. Periodic large scale funding factored for repair / replace.

Useful Life:  
25 yearsRemaining Life:  
6 years

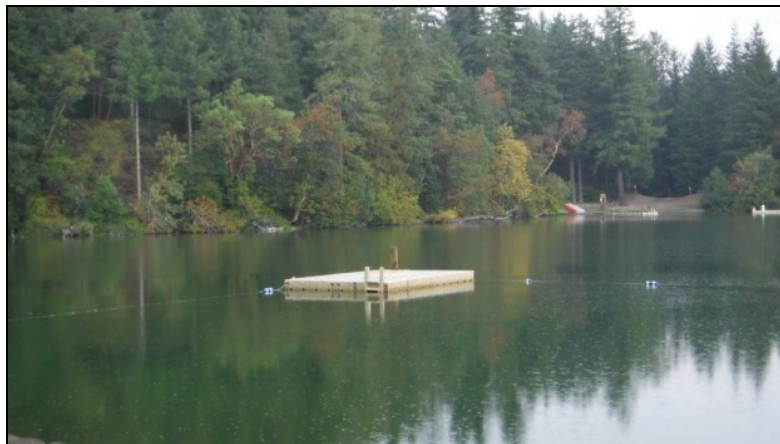
Evaluation: We viewed from a distance. No obvious issues observed or reported to us. Plan for replacement as shown.

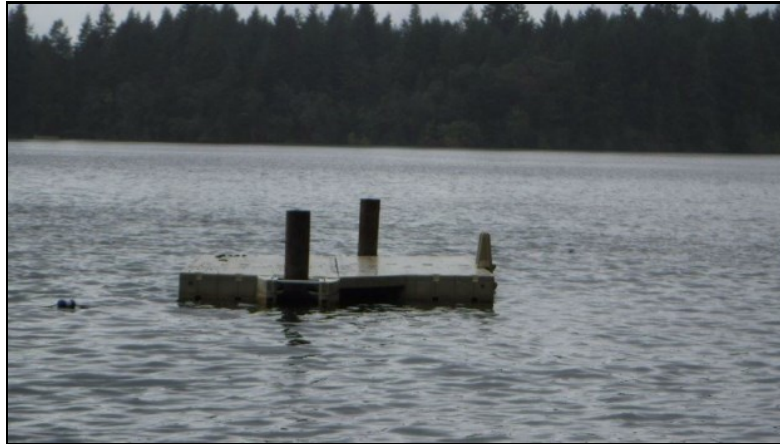
Evaluation: This component includes the fishing/access dock at the shore as well as the water surrounded, swim dock. No problems observed of modular type docks (non-wood components). Association records reviewed during last reserve study indicate EZ-dock in 2006. Although sturdy product, anticipate eventual replacement as shown here due to typical damage/deterioration that will occur over time in this highly exposed area.

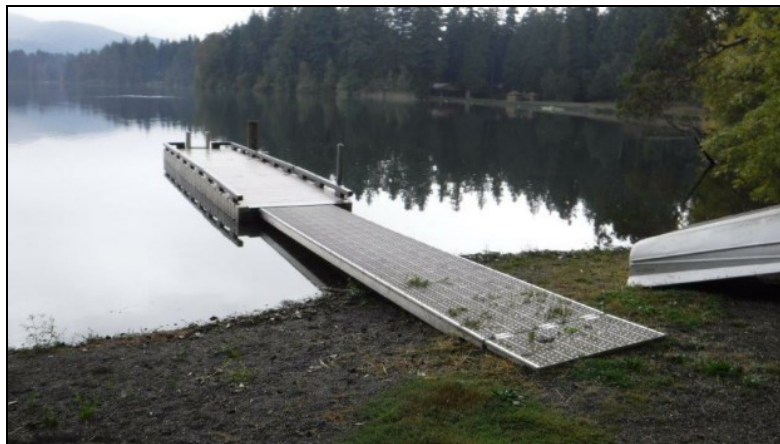
Evaluation: This component includes the fishing/access dock at the shore as well as the water surrounded, swim dock. No problems observed of modular type docks (non-wood components). Association records reviewed during last reserve study indicate EZ-dock swim in 2009 and fishing/access 2010. Although sturdy product, anticipate eventual replacement as shown here due to typical damage/deterioration that will occur over time in this highly exposed area.

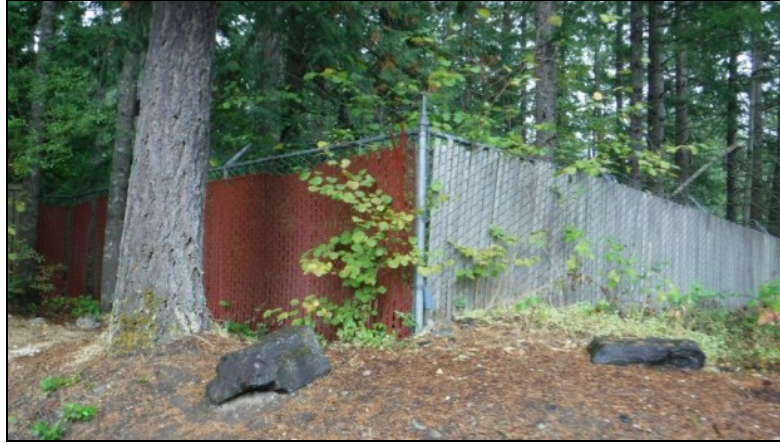
Evaluation: We viewed some sample areas. As shown in Associations' 2018 budget, some work anticipated in 2018. Service life of galvanized link fence is typically in the 40 to 50 year range in our experience. Although we do not anticipate comprehensive replacement project as a single project, we recommend funding for periodic larger localized repair/replacement projects as shown. This could vary and to be used for placeholder. Inspect at least annually to assess needs.

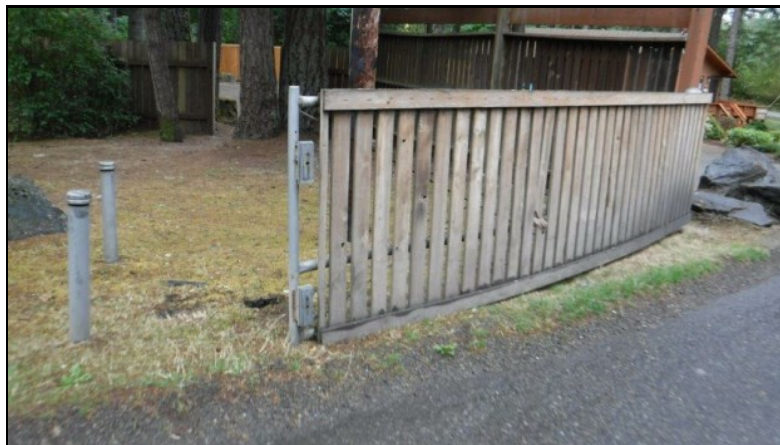
Evaluation: Some local deterioration but no major or widespread damage noted. Plan for replacement as shown.

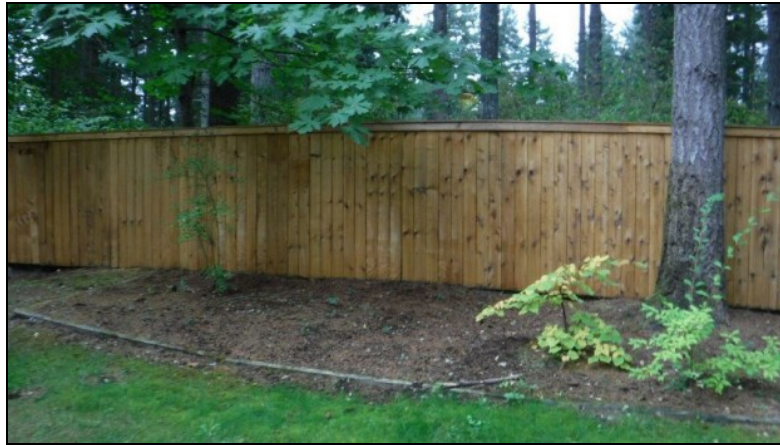
Evaluation: No obvious instability or major damage/deterioration of wood board fencing observed. Plan to replace at roughly the time frame below. Typical failures occur from deterioration through end grains, contact with ground and surrounding landscape.

As routine maintenance, inspect regularly for any damage and repair as needed. Avoid unnecessary contact with ground, sprinkler patterns and surrounding vegetation. Regular cycles of stain/paint will help to maintain appearance. Painting or staining the fence has a higher overall life cycle cost but may extend life somewhat in addition to aesthetic benefit. As discussed with maintenance manager, recently stained and funded out of operating budget.

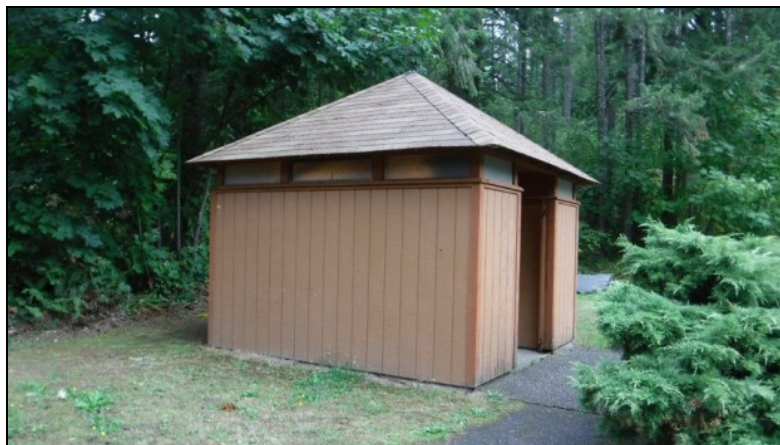
Evaluation: No specific issues of this restroom noted and no problems reported to us. Inspect at least annually and repair/replace locally as needed. Plan for eventual larger refurbishing as shown here. Project can vary and may or may not include roof replacement, fixture replacement, siding work, etc. Evaluate prior to project to define scope.

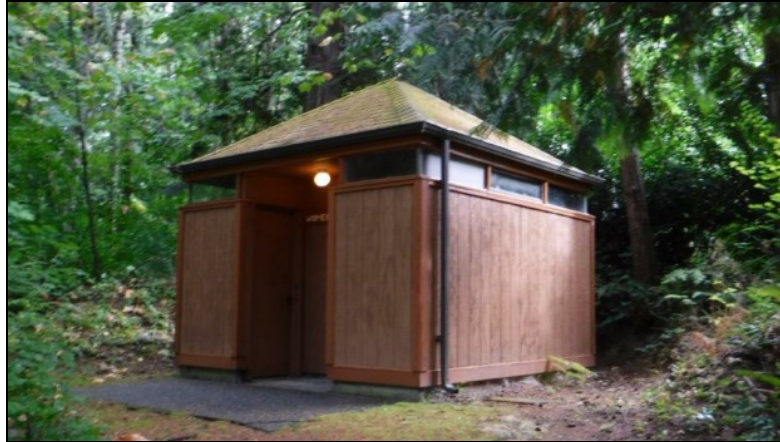
Evaluation: No specific issues of this restroom noted and no problems reported to us. Maintenance manager reports fiber-cement siding was installed at this building in 2016. Although siding was replaced in 2013, wood siding had to be subsequently replaced with fiber-cement due to condition.

Inspect at least annually and repair/replace locally as needed. Plan for eventual larger refurbishing as shown here. Project can vary and may or may not include roof replacement, fixture replacement, siding work, etc. Evaluate prior to project to define scope.

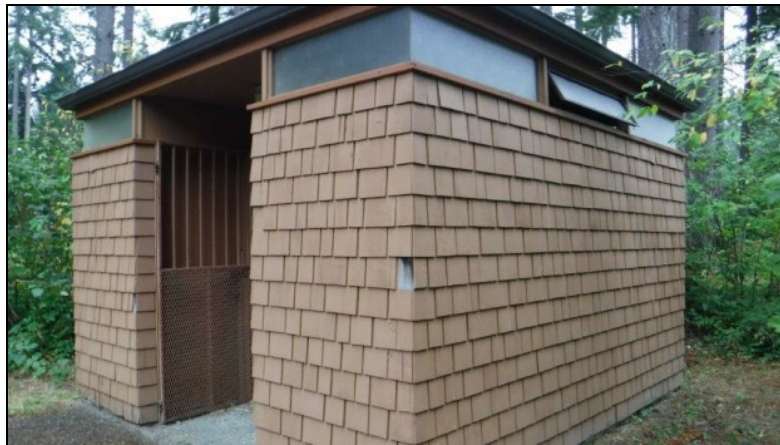
Evaluation: As shown in Association planning documents, refurbishing of this restroom is listed as a 2018 project. Maintenance Manager reported to us during our September 2017 site visit some discussion whether this restroom will be retained. Some issues with septic at this site reported in 2017. We are assuming will be retained and work as budgeted by Association will occur in 2018. Plan for eventual larger reburbishing as shown here. Project can vary and may or may not include roof replacement, fixture replacement, siding work, etc. Evaluate prior to project to define scope.

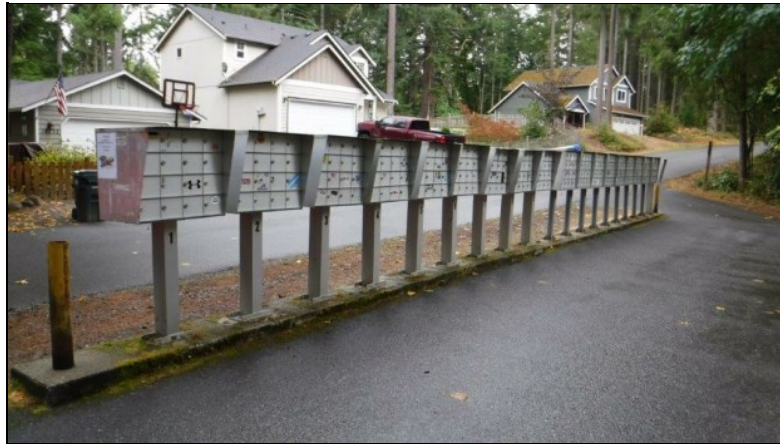
In our experience, it is best to plan for total replacement at roughly the time frame below due to constant usage and wear over time. As routine maintenance, inspect regularly, clean by wiping down for appearance, change lock cylinders, lubricate hinges, and repair as needed from operating budget. Note: USPS has a limited budget for replacement and should not be relied upon for purposes of long term financial planning.

Useful Life:  
20 yearsRemaining Life:  
1 years

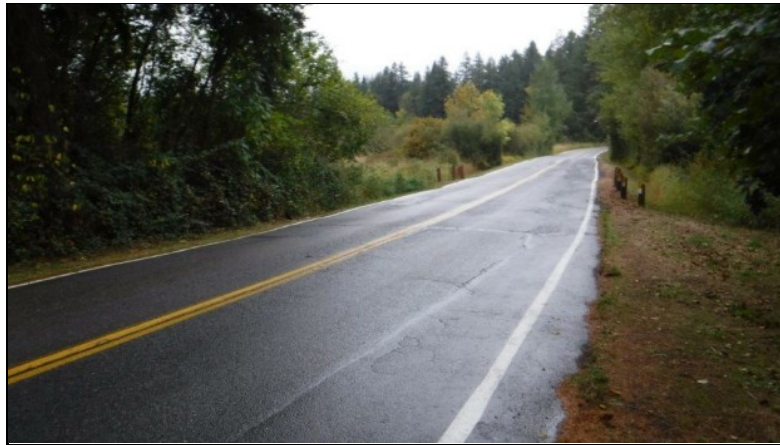
**Comp #: 200 Road Project D-1: Resurface**

Useful Life:  
30 years

Remaining Life:  
0 years

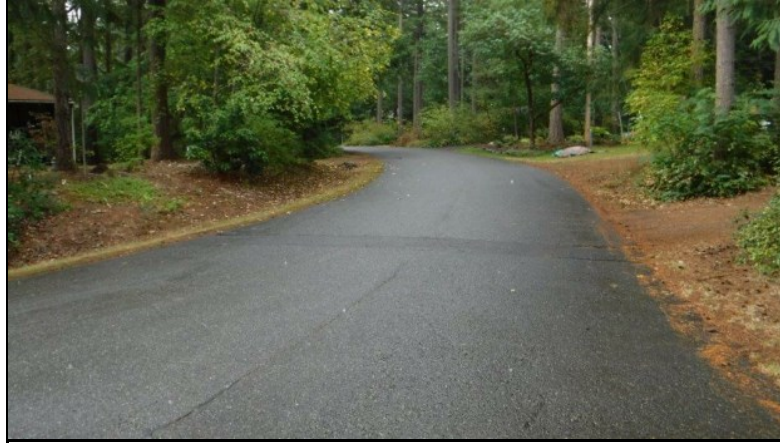
Evaluation: Phasing of road work, coinciding with water main replacement - see component #200 for notes.

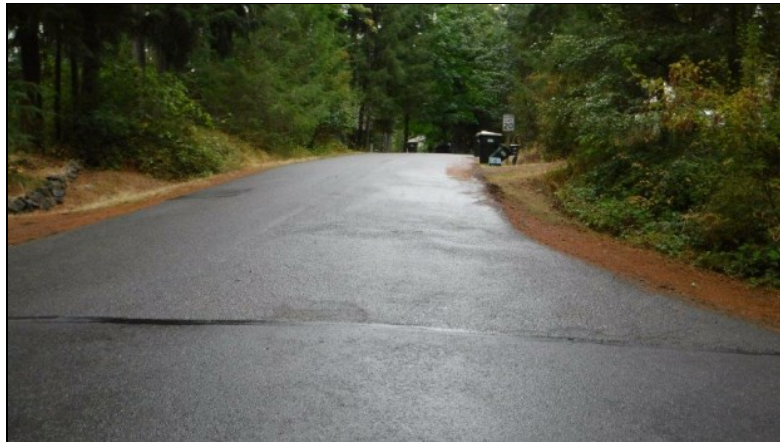
Evaluation: Phasing of road work, coinciding with water main replacement - see component #200 for notes.

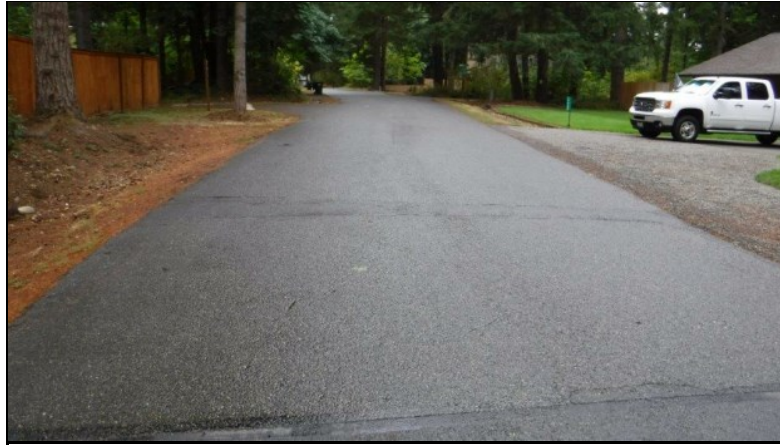
Evaluation: Phasing of road work, coinciding with water main replacement - see component #200 for notes.

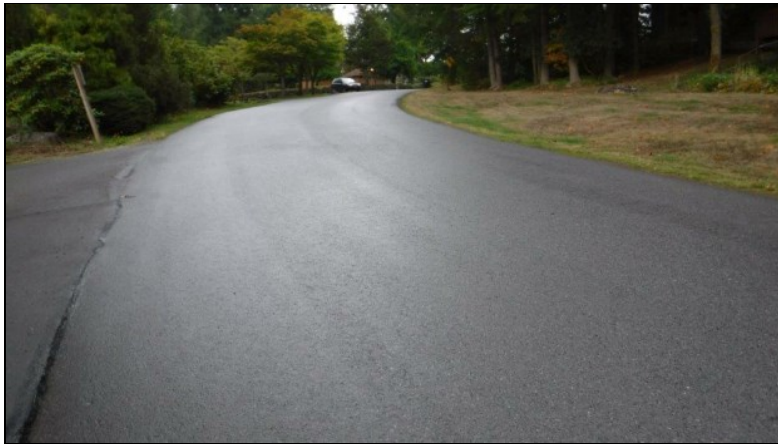
**Comp #: 211 Roads replaced in 2002**

History: Replaced in 2002

Evaluation: This component represents future cycles of roadway that were resurfaced in 2002 along with water main replacement.

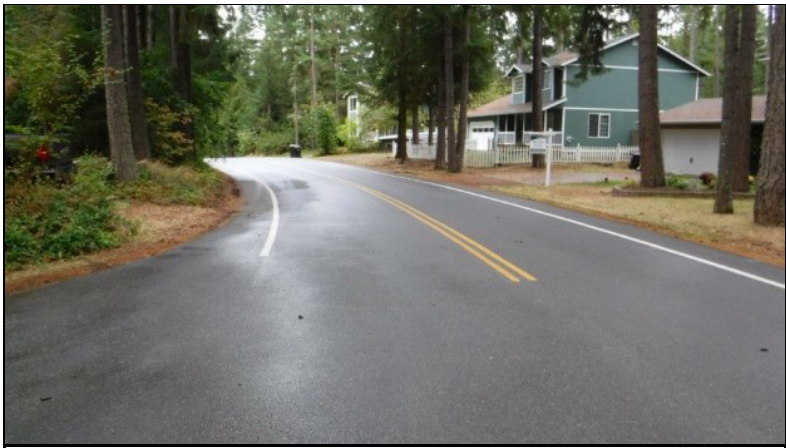
Comp #: 212 Roads replaced in 2009

History: Replaced in 2009

Evaluation: This component represents future cycles of roadway that were resurfaced in 2009 along with water main replacement.

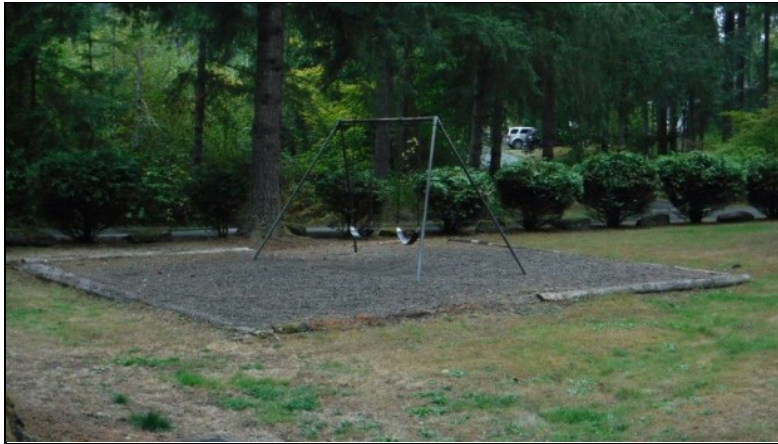
Replacement cycles vary depending on the amount of use/abuse, however expect extensive park area renovation at roughly the time frame listed below. Inspect for stability, damage and excessive wear and utilize maintenance funds for any repairs needed between replacement cycles.

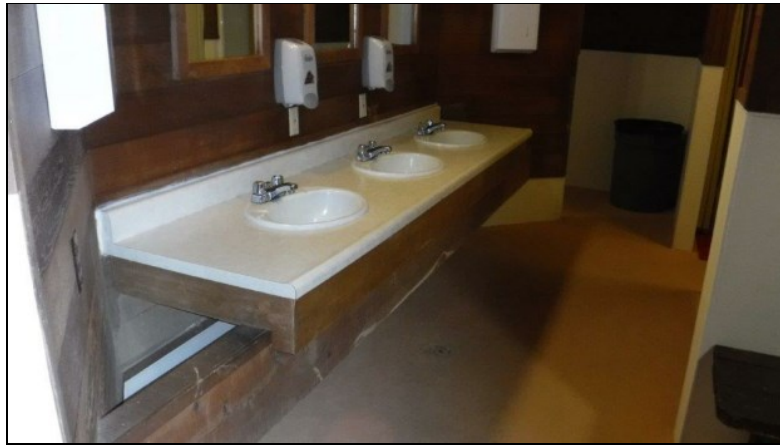
History: 1997 repair \$37,620, 1998 \$17,280 2009 \$4,964 (stalls)

Evaluation: Some variation in condition/materials as various upgrades throughout the years (see Project History section).

This component suggests setting aside funding for periodic aesthetic refurbishing. Many communities replace such items as furniture, fixtures, lighting, décor, etc. at regular intervals to maintain this important community area. A funding allowance is used below for financial planning purposes; cost can vary widely depending upon scope, desires of residents.

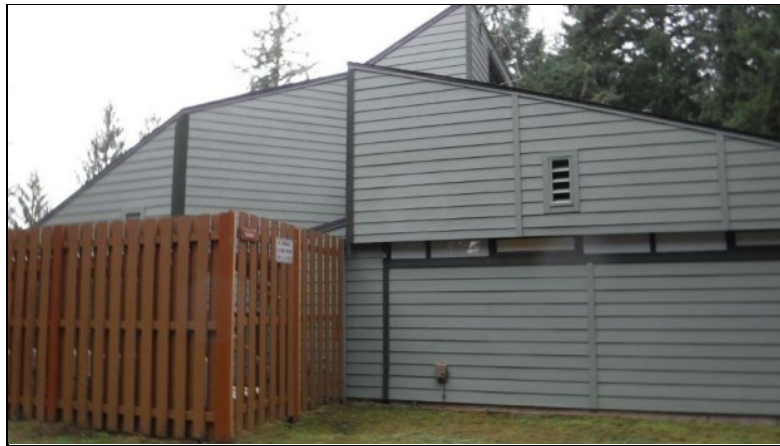
History: Replaced in 2017

Evaluation: Fiber-cement horizontal siding was installed in 2017 replacing wood shingle siding. Surfaces appear in good condition at this time with no significant wear/deterioration. We assume wood trim.

Replacement will ultimately be needed due to the failure of the underlying waterproofing degrading over the decades, and/or the end of the useful life of the siding materials from general aging. Many factors influence the useful life, including exposure to (or protection from) wind driven rain, and the quality of the waterproofing and flashing beneath the siding. Evaluate the siding and the critical underlying waterproofing (typically building paper or house-wrap) more frequently as the remaining useful life approaches zero years. Adjust remaining useful life as dictated by the evaluation.

Project costs can vary depending upon materials chosen and the condition of the underlying structural framing when exposed. We recommend the Board conduct research well in advance in order to define scope, timing and costs, including plan for some margin of contingency.

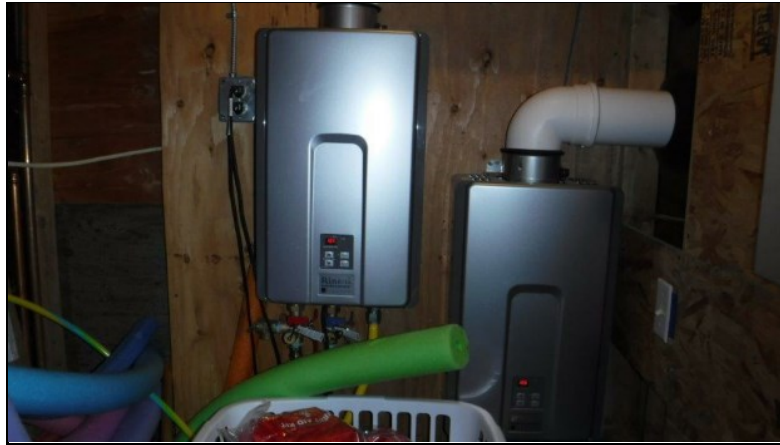
History: Replaced most likely in 2015

Plan for replacement as shown. As part of routine maintenance, inspect periodically and follow manufacturer guidelines.

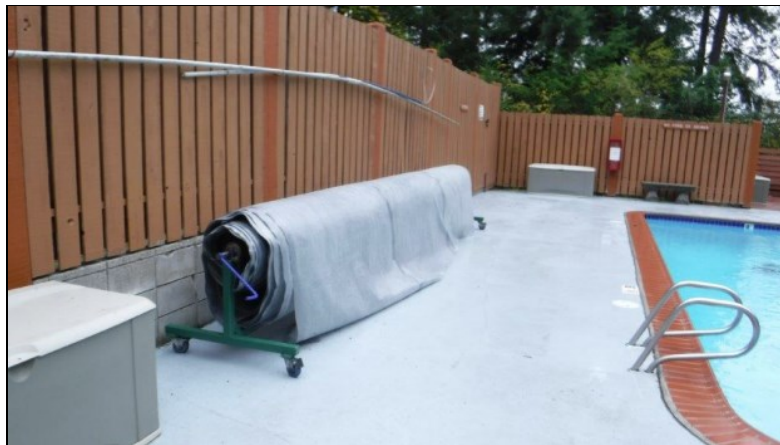
Evaluation: No problems reported of metal reel. Lower cost item that can be repaired/replaced as needed out of the operating budget with no predictable basis for reserve funding.

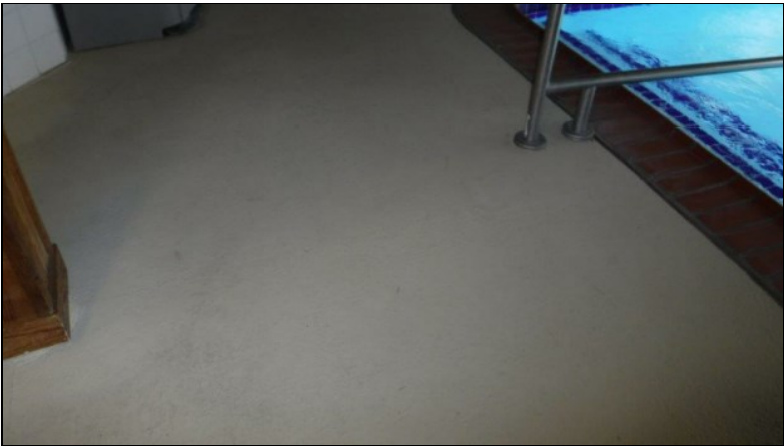
Evaluation: Coatings redone periodically as shown in project history. Scope varies as some needed striping and others simple painted on coating. Plan for major refurbishing/resurface of coating as shown. Note: concrete itself is in serviceable condition and there is no predictable basis for large scale replacement of the deck itself (most significant work around 2000 for ~\$20,000). If conditions change, funding should be included in a reserve study update (~\$14/sq ft for reference).

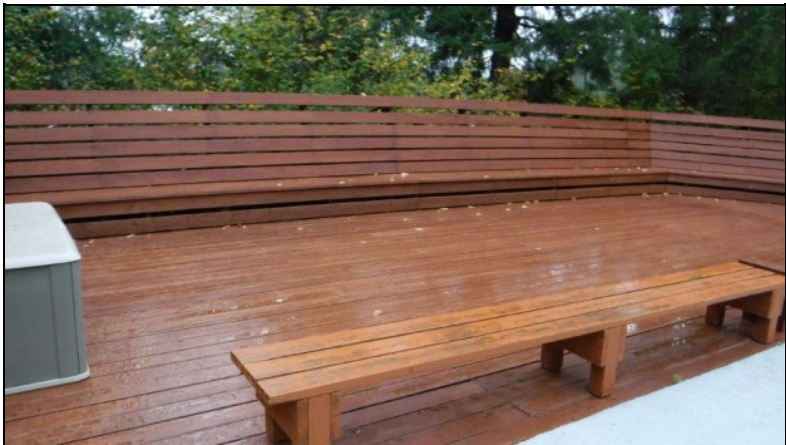
Evaluation: Deck surface is open boards that allow water to drain off between them. No obvious major damage/deterioration observed from top of deck; we did not view underlying structural components. Surfaces have been stained.

Funding is for replacing existing walking surface materials with like kind material, which is factored below. Costs may be greater if the structural framing is found to need repair or replacement. Inspect at least annually and repair as needed. As part of maintenance, apply water repellant stain/preservative at least every other year. Almost all exterior wood exposed to Puget Sound area weather will decay over time and require replacement. Options for a longer lasting deck include using thick wood boards or a composite product (increased cost).

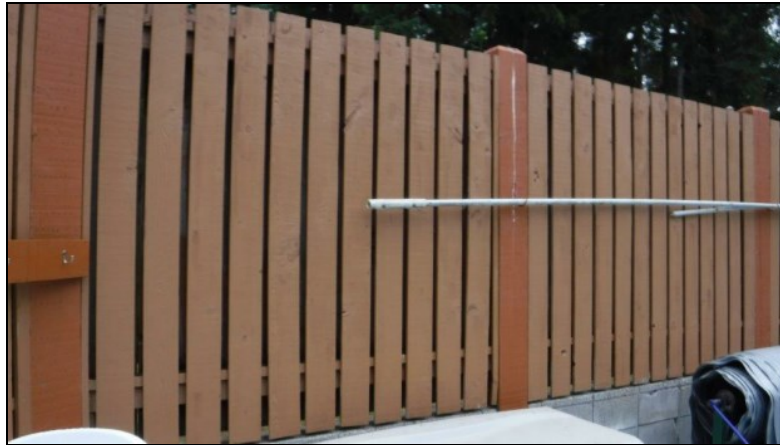
**Comp #: 226 Pool - Fence Replacement**

History: Anticipated to be replaced in 2018

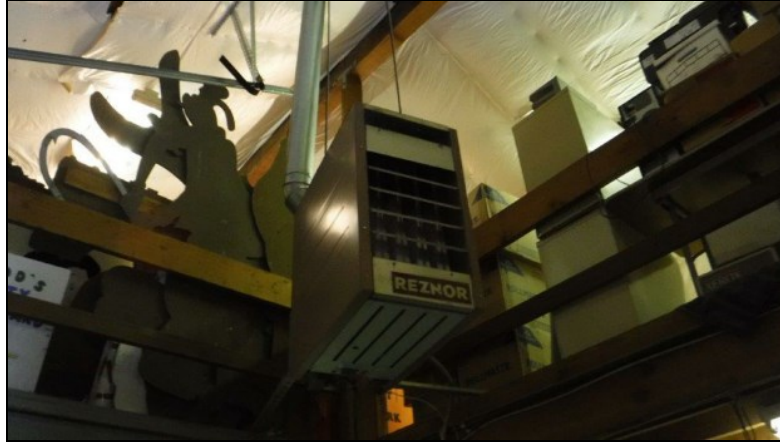
Plan for replacement as shown. Have serviced/maintained professionally.

Useful Life:  
25 yearsRemaining Life:  
5 years

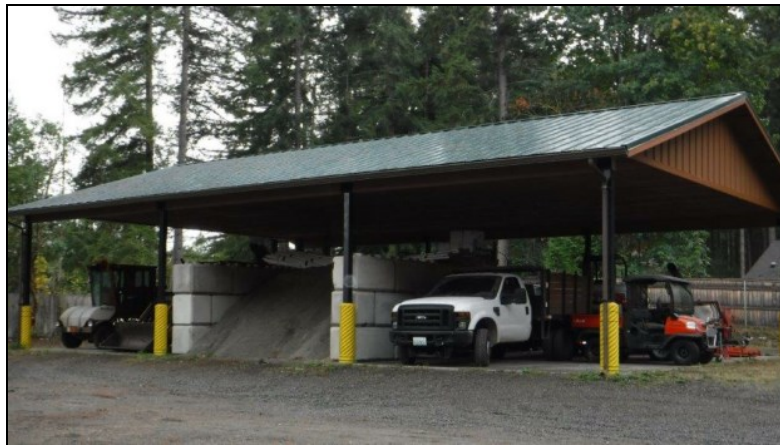
Evaluation: This structure was erected new in 2013. No problems reported to us. Plan for replacement as shown. As structure ages, might be determined that portions of building can be maintained/repared but at this time entire building replacement factored.

Useful Life:  
50 yearsRemaining Life:  
44 years

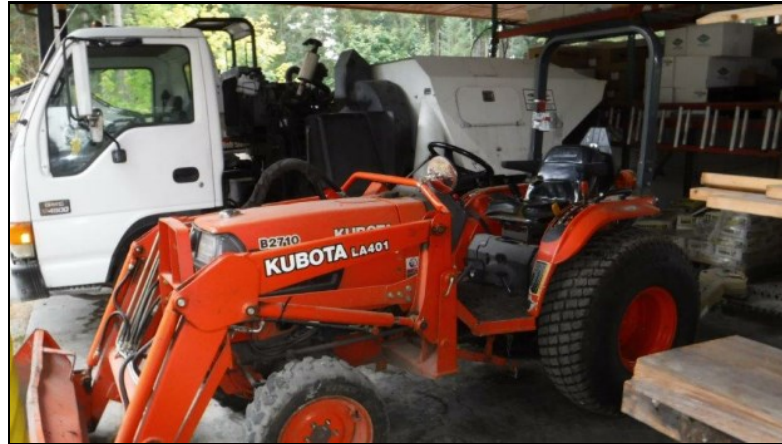
Plan for replacement as shown. Inspect and service regularly to extend life.

Useful Life:  
20 yearsRemaining Life:  
0 years

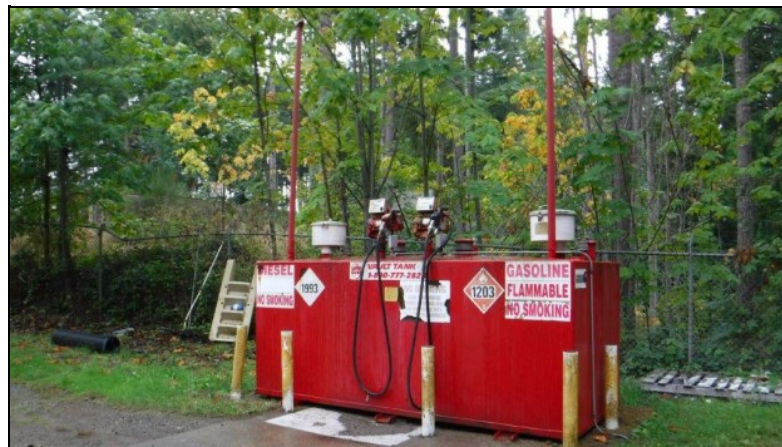
Over time these will deteriorate and should be planned for replacement as shown; could vary.

Useful Life:  
40 yearsRemaining Life:  
15 years

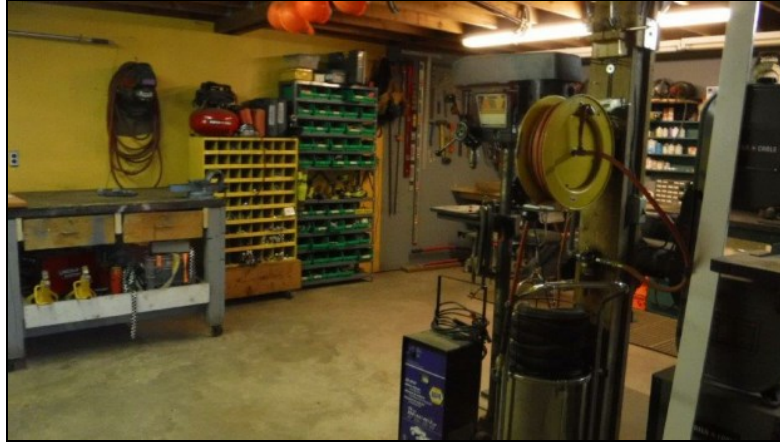
Evaluation: There are numerous small tools and accessories in the shop area. Failure rate and replacement needs are likely to be intermittent and not on a large scale cyclical basis as reserve project. Evaluate condition and needs each year and incorporate any funding needs within general operating / maintenance budget.

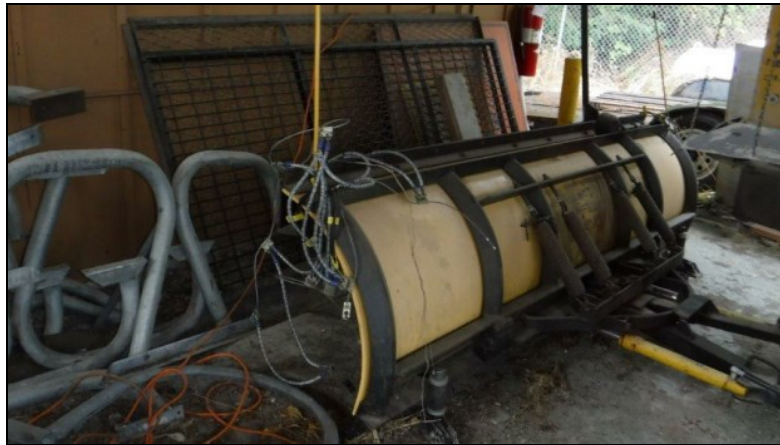
Evaluation: Older piece that should be planned for replacement as shown.

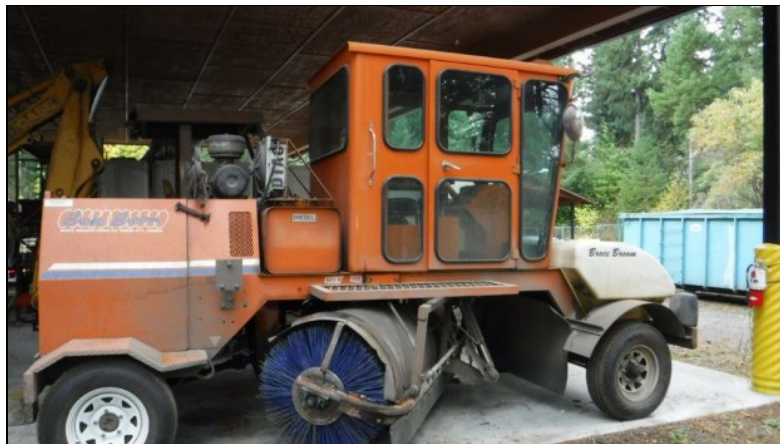
Evaluation: Aging equipment nearing the end of it's useful life. Plan for replacement as shown here.

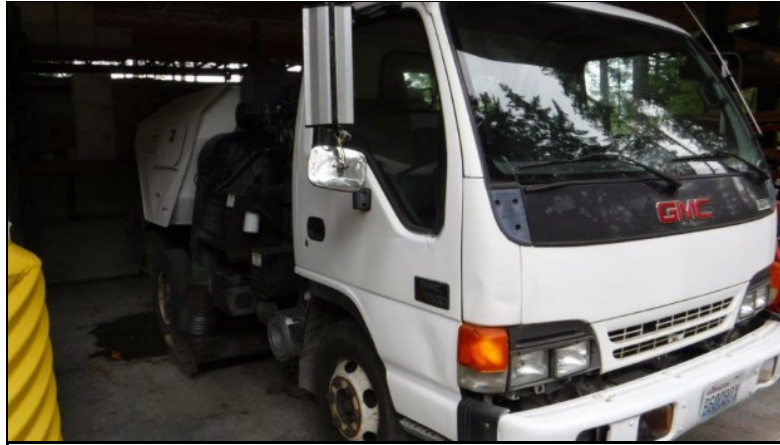
Evaluation: Reportedly continues to perform, although over 300,000 miles. Nearing time for replacement as shown.

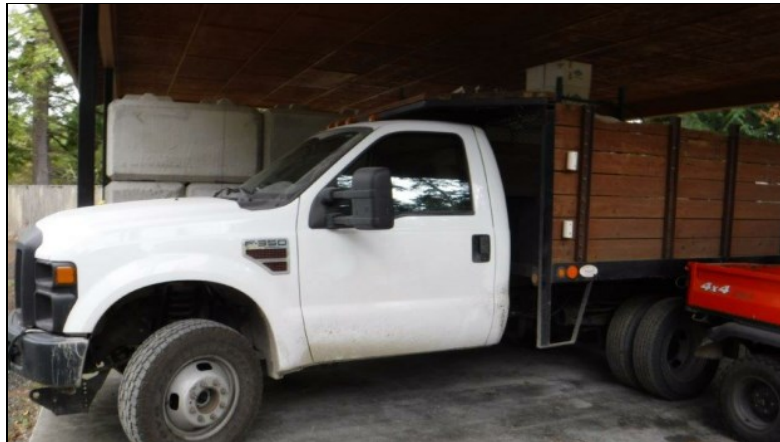
Evaluation: Some reported issues currently with cooling system, head. For now, schedule maintained. Plan for replacement as shown; include sander (#328).

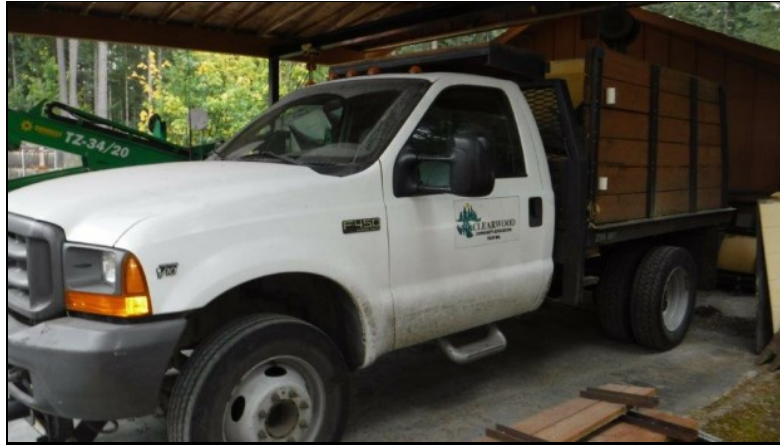
Evaluation: While functional, has reached age where replacement truck might be more cost effective. Plan for replacement as shown. Sander for this truck (#327) coincides.

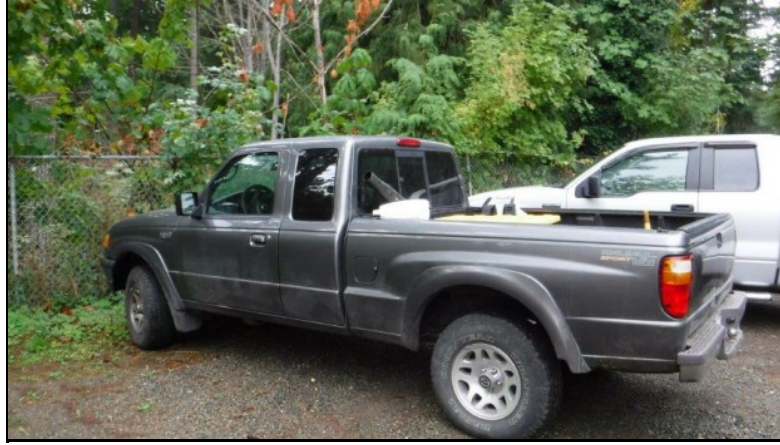
Evaluation: This used truck was purchased in 2015 replacing previous 1999 Dodge Dakota truck. No problems currently reported.

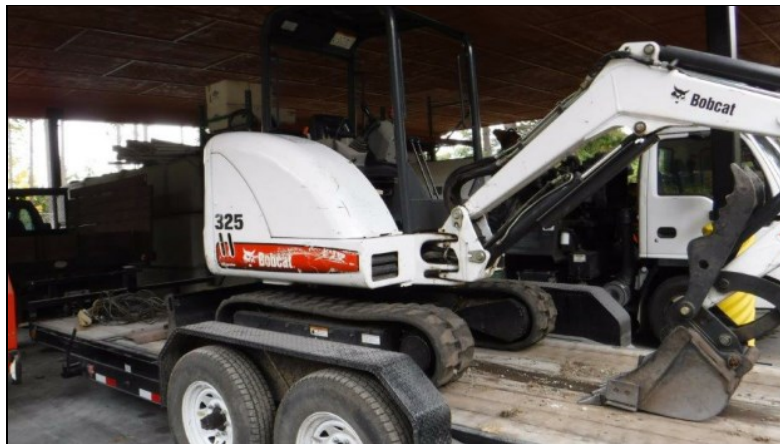
Evaluation: No problems reported of this trailer. Plan for replacement as shown.

Useful Life:  
10 yearsRemaining Life:  
4 years

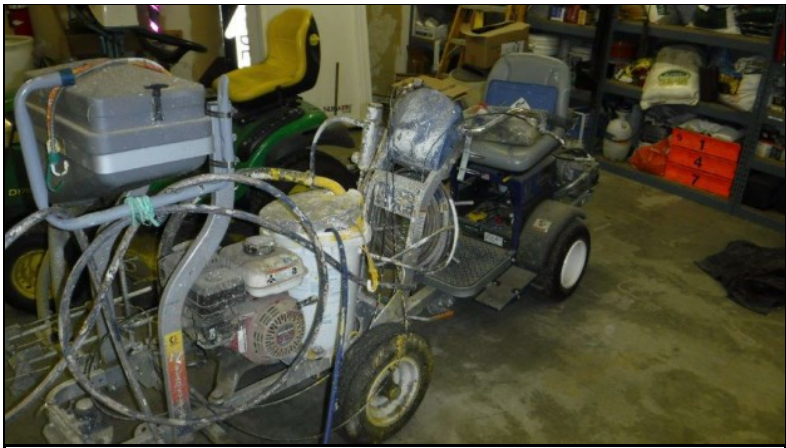
Evaluation: No problems reported of this unit. Ten year replacement cycles factored.

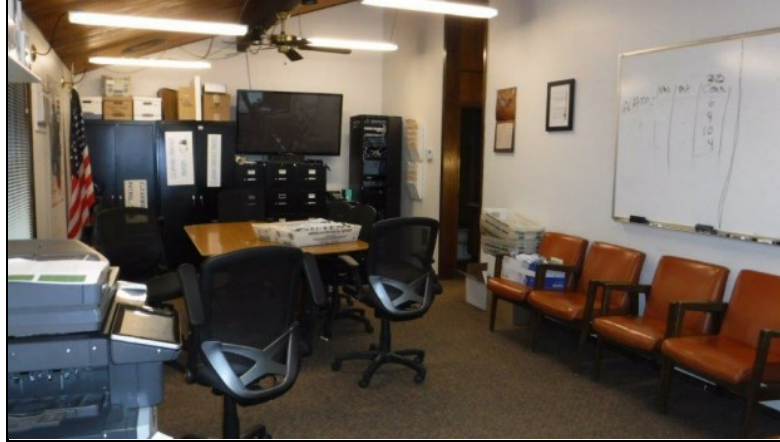
Evaluation: Varying age and condition. Typically the various furnishings can be replaced as needed out of the operating budget with no anticipation to be needed all at one time. Assumption is, individual replacement can be funded out of the operating budget as needed.

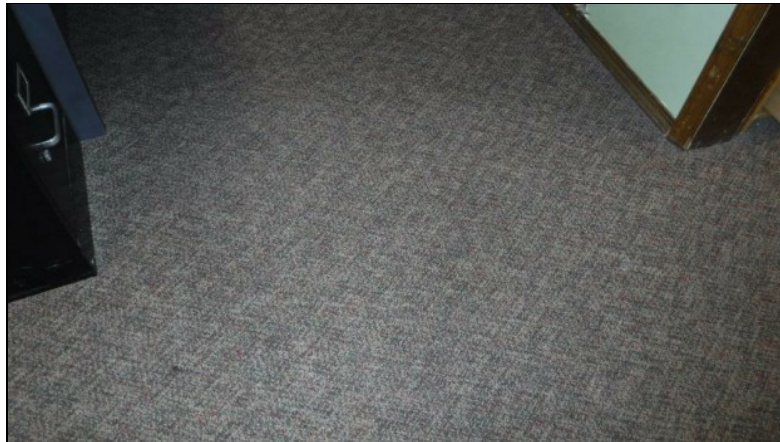
Evaluation: No major staining/wear of carpeted flooring and no major deterioration of painted surfaces. Plan for replacement of flooring and repainting interior surfaces as shown here.

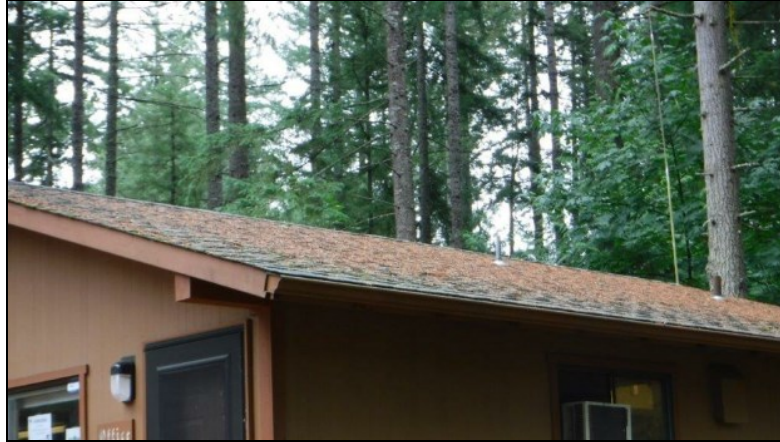
Evaluation: We had limited visibility from our ground level inspection. We noted accumulation of organic debris/needles at this time with many large trees in the immediate vicinity. No problems reported to us however, and no major obvious damage noted. A reserve study conducts a limited visual review for budget purposes, and many of the critical waterproofing and ventilation items of the roof are not readily visible. For a full evaluation have a professional roof consultant/contractor perform a thorough up-close survey of your entire roof system, including attic inspection (if any).

Plan for replacement as shown. As routine maintenance, many manufacturers recommend inspections at least twice annually (once in the fall before the rainy season and again in the spring) and after large storm events. Promptly replace any damaged/missing sections or any other repair needed to ensure waterproof integrity of roof. Keep roof surface, gutters, and downspouts clear and free of moss or debris.
