Update "With-Site-Visit" Reserve Study

Clearwood Water Systems Yelm, WA

Report #: 7223-5
For Period Beginning: January 1, 2019
Expires: December 31, 2019

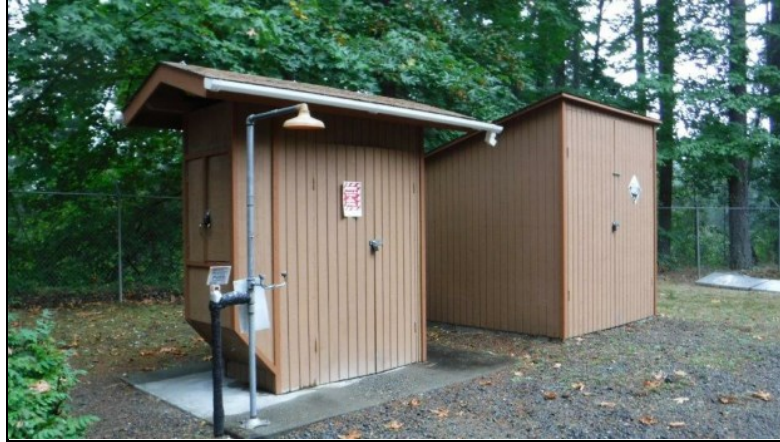
No records or information provided to us regarding when last survey was completed.

Useful Life:
3 yearsRemaining Life:
0 years

Best Case: \$ 5,500

Worst Case: \$ 6,600

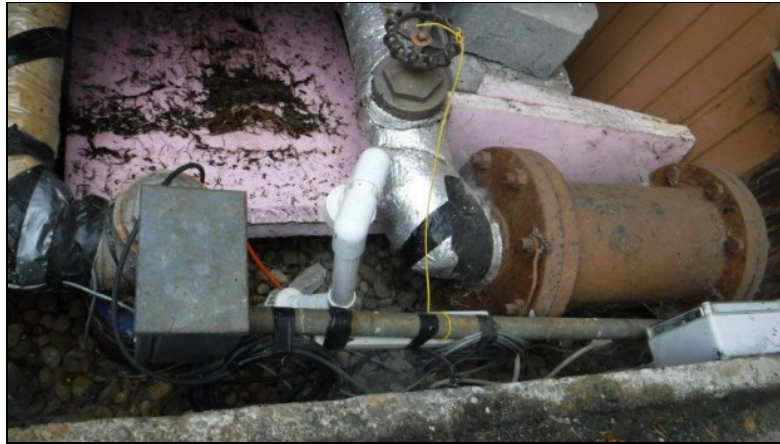
Comp #: 104 Well #1 - Replace Casing

Useful Life:
80 years

Remaining Life:
34 years

Best Case: \$ 126,000

Worst Case: \$ 169,000

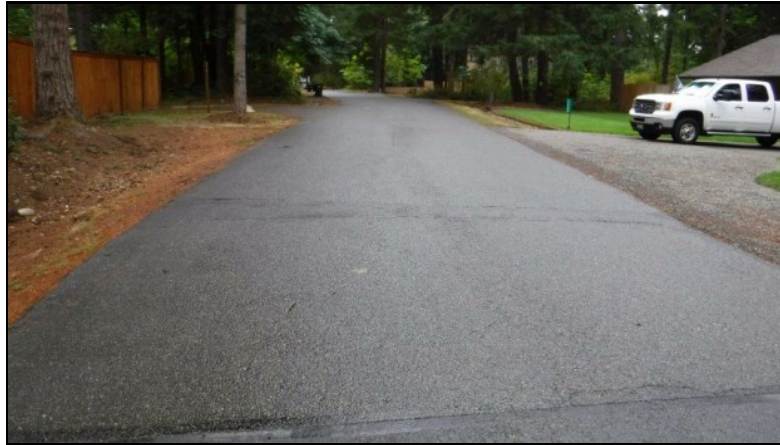
Evaluation: This component factors phase of recommended water main replacement program - see component #300 and community Water System Plan for supporting detail of assumptions.

Useful Life:
60 yearsRemaining Life:
19 years

Best Case: \$ 278,000

Worst Case: \$ 321,000

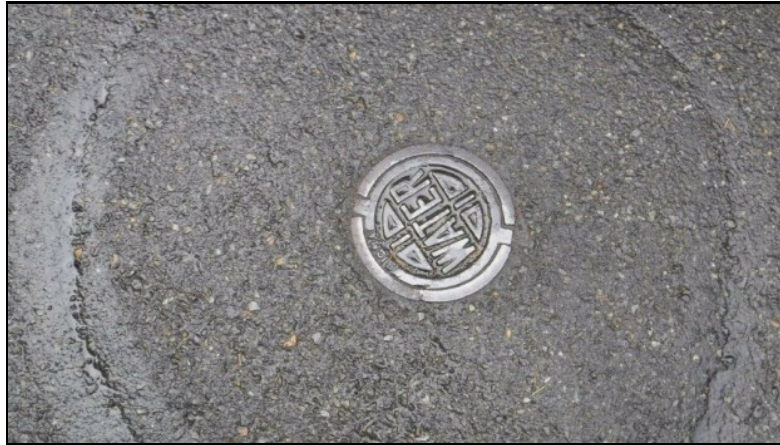
Evaluation: This component factors cyclical replacement of gate valves, corresponding with main replacement program. Photo is typical and does not represent phasing.

Useful Life:
30 yearsRemaining Life:
13 years

Best Case: \$ 93,300

Worst Case: \$ 115,000

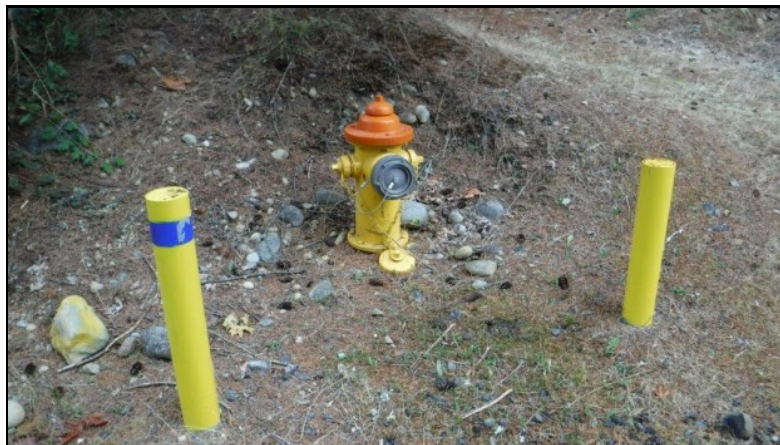
Evaluation: Note: a Water Systems Plan is currently underway (2017), however not completed at the time of our report preparation late 2017, thus we are still relying on 2011 WSP and current management information. Cyclical replacement of hydrants factored - see subsequent components. Photo typical - does not represent phasing.

Useful Life:
30 yearsRemaining Life:
24 years

Best Case: \$ 4,900

Worst Case: \$ 6,000

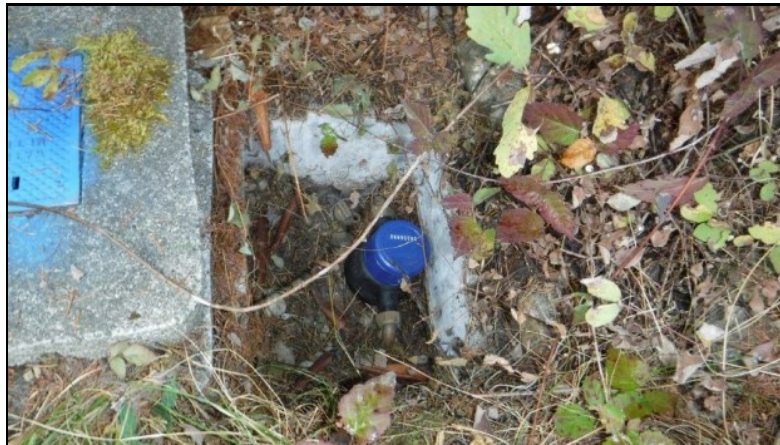
Evaluation: Note: a Water Systems Plan is currently underway (2017), however not completed at the time of our report preparation late 2017, thus we are still relying on 2011 WSP and current management information. Ongoing replacement project occurs annually for new meters and setters. As discussed in the past, manager estimates useful life of the meters to be 10 years, so program is to replace on a rotating basis for approximately 1/10 of total meters each year, reportedly factored within reserves.

Useful Life:
10 yearsRemaining Life:
3 years

Best Case: \$ 6,800

Worst Case: \$ 8,000

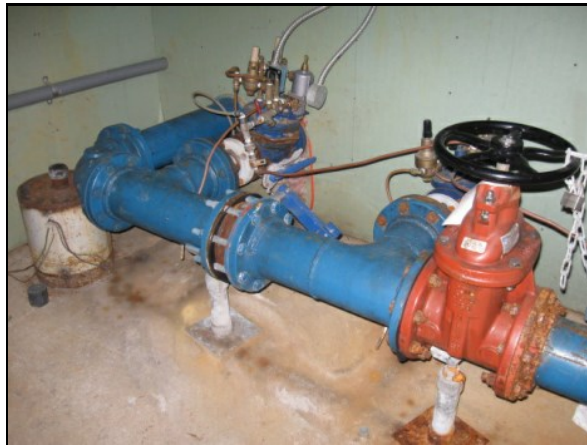
Evaluation: Note: a Water Systems Plan is currently underway (2017), however not completed at the time of our report preparation late 2017, thus we are still relying on 2011 WSP and current management information. Large flow control valves have reportedly been significantly repaired twice within the last ten to fifteen years. This component factors reserve funding at 5 year interval to repair one of the two Cla-Val valves. Note: photo here is from previous inspection.

Useful Life:
5 yearsRemaining Life:
0 years

Best Case: \$ 4,300

Worst Case: \$ 5,600

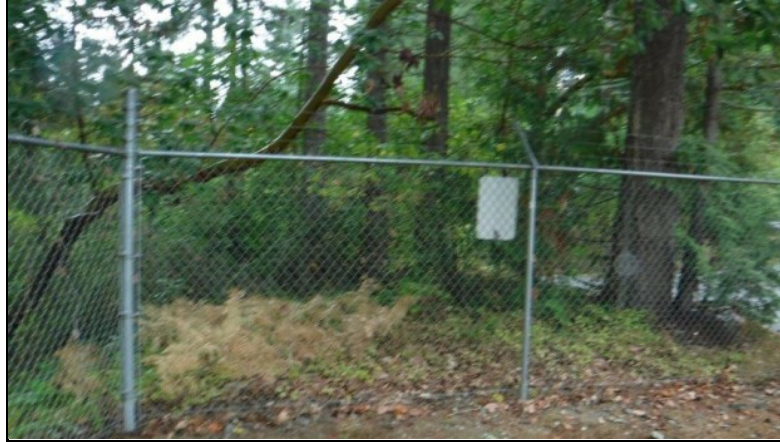
Comp #: 411 Well Sites Fence - Replace**Quantity: ~ 720LF, chain link**

Evaluation: No obvious major or widespread damage observed or reported. Depreciation schedules from 2004 indicate fencing was installed in 1997 / 1998. Typical service life is in the 30 year range. Treat local repair needs as general maintenance expense and plan for eventual total replacement as reserve project.

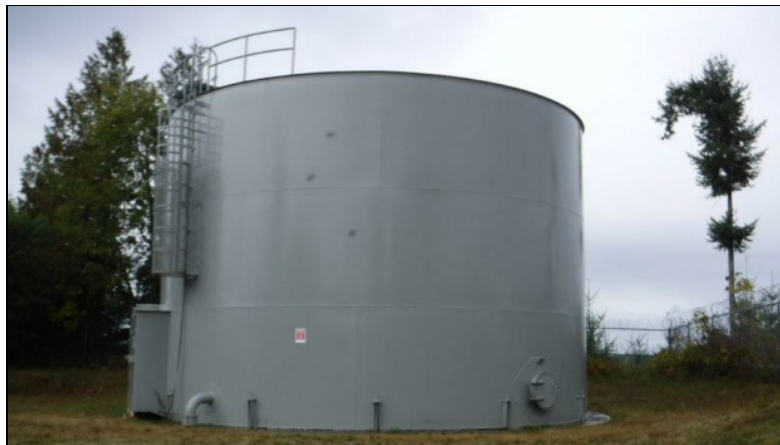
Comp #: 412 Reservoir Fences - Replace**Quantity: ~ 500 LF, chain link**

Evaluation: No obvious major or widespread damage observed or reported. Typical service life is in the 30 year range. Treat local repair needs as general maintenance expense and plan for eventual total replacement as reserve project.
