# **Reserve Study Level II**

**Prepared for Clearwood HOA**

**2022 Fiscal Year**

Prepared by CEDCORE, LLC

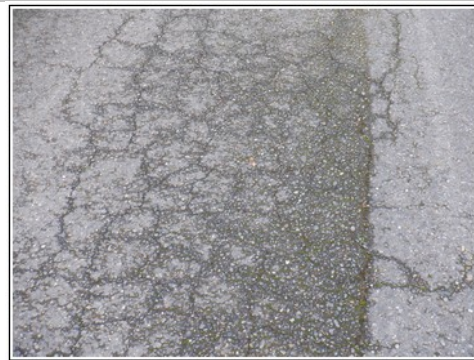
**Site/Grounds - Asphalt Roads: Repairs/Patching**

Generally fair condition of asphalt surface with some localized areas that are cracked and in need of patching. We recommend regular patching be done to maximize the life of the asphalt. Patching will prevent further deterioration to the gravel base.

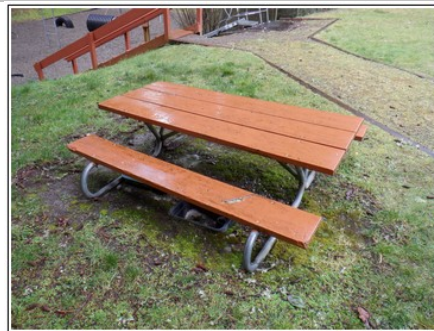
Placeholder amount pending count of benches and picnic tables and age of items to establish likely year of replacement.

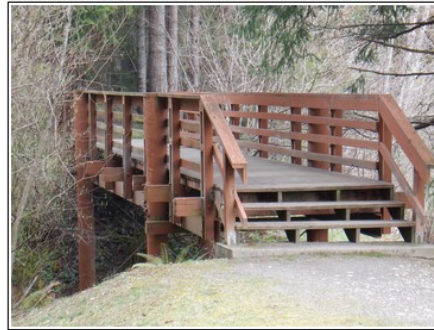
## Site/Grounds - Bridge, Rampart: Repair/Replace

Repaired in 1990, 2004 & 2008

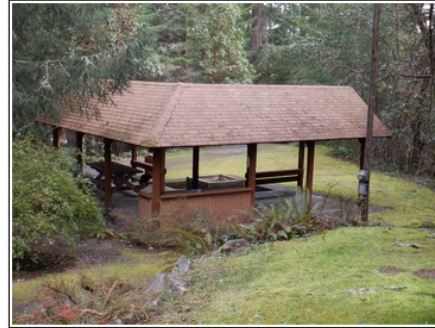
Constructed in 2009. Pole barn style cabana.

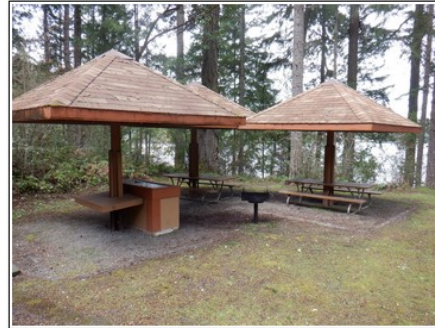
Picnic pods new in 2007. Umbrella style that is rotting in the valleys.

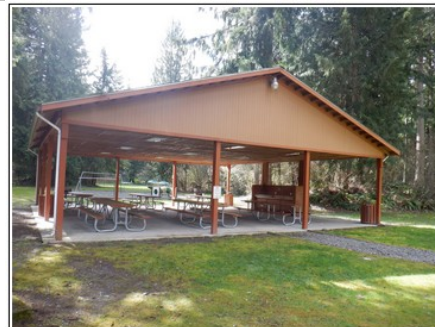
Major work done in 2007 with additional work done in 2014/15. Pole Barn style cabana.

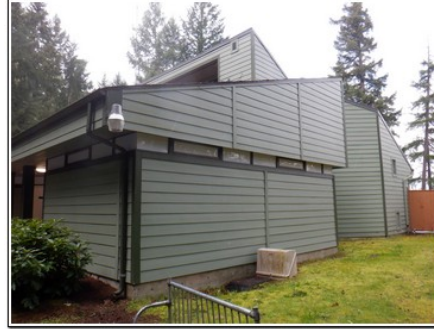
Generally good condition with no known water intrusion or concerns. We strongly recommend regular inspections and repair to ensure the integrity of the building envelope. Reserve funding recommended for eventual replacement at the typical life expectancy of 30 to 40 years. Should patterns of repair arise, additional funding may be included in future reserve studies, however, at this time there is no need.

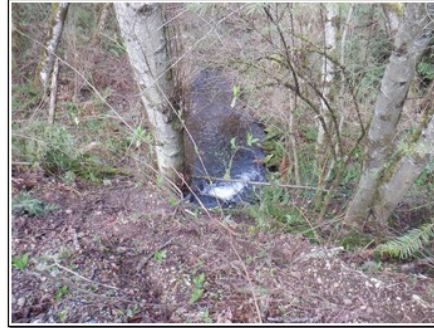
MA Waterman Consulting 5/15/2020 WY Report: The inlet side of the culvert underneath Clearlake Blvd SE appears to be somewhat flattened

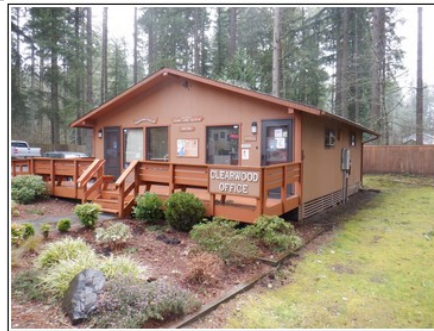
Planned replacement in 2021. The elevated decks in some of the community have spaced wood boards. Currently the surface of the decks are in generally fair condition.

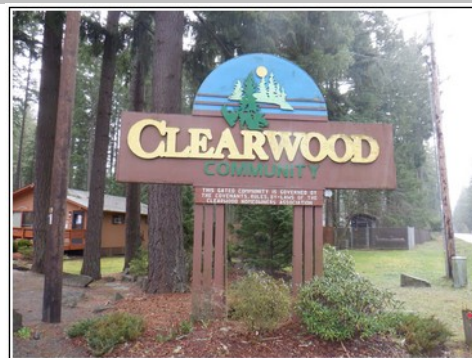
Good condition of wood signs. These units need to be painted regularly to maximize the life expectancy. Reserve funding recommended.

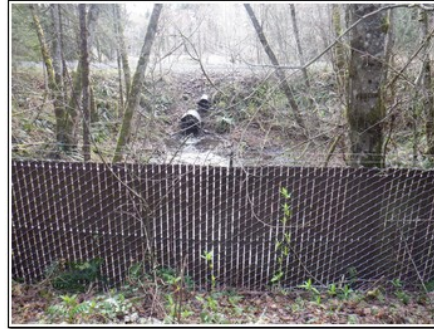
There is approximately 5 miles (26,400 linear feet) of chain link fencing to be maintained, repaired and replaced as needed. This item is for maintenance and repair with only minor amounts to be replaced. Full replacement cost would be approximately \$800,000. Originally installed in mid 1970's so approaching 50 years old.

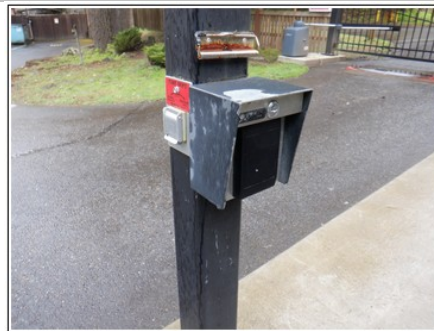
Installed in 2018. Where you swipe card at gate. x1 reader at front gate & x1 reader at back gate

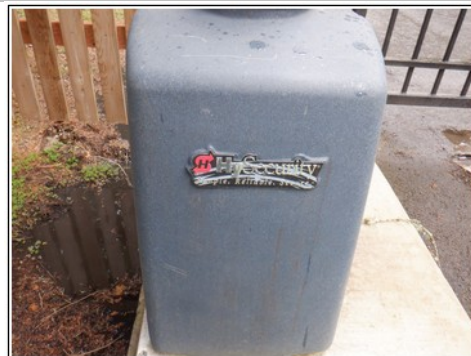
Installed in 2018. Good functional condition with no concerns at this time. We recommend working with a qualified vendor to develop and establish an operating and maintenance plan. Reserve funding recommended for cycles of replacement. x2 front gate / x2 back gate - swing gate.

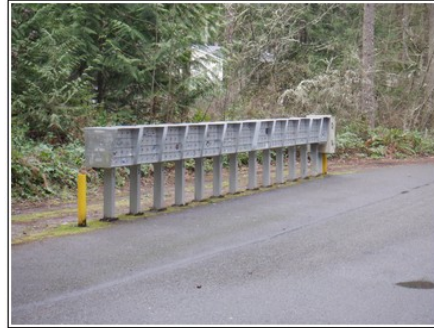
Planned replacement in 2021. Need parcel boxes added. Clean as needed to maintain appearance. Oil hinges to maintain ease of operation. We suggest planning for eventual replacement of the mailboxes to ensure functionality and community aesthetics.

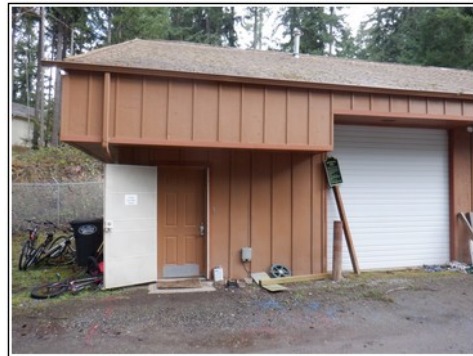
Planned for 2021. Good condition at this time with no unusual or significant peeling or fading of exterior surfaces. Regular paint cycles are important to maintaining and protecting the HardiPlank siding. Inspect regularly touch up paint and caulking as needed from the operating budget. To optimize the painting costs, we recommend that a professional painting and/or coating inspector be retained to inspect the existing paint film thickness and adhesion. A painting inspector can also prepare a written specification which would ensure that selected painting contractors are all quoting on the same products and methods of painting. The painting inspector can also perform wet film tests while the painting is being done to ensure that the correct amount of paint is being applied. The painting costs can be further optimized by repainting those wall elevations that receive the most weathering from sun and rain are repainted frequently enough. Similarly, those elevations, such as north facing walls, that do not require repainting as frequently the repainting cycle can be extended.

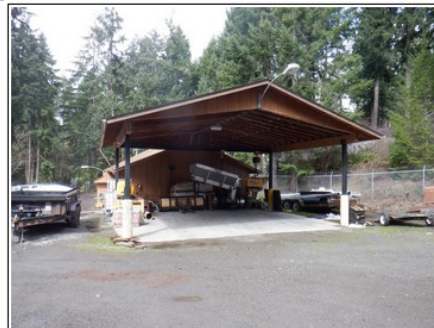
Installed in 2013. Good condition with no substantial damage or unusual deterioration noted. roof/ concrete pad next to main building. Free standing - pole barn roof no sides

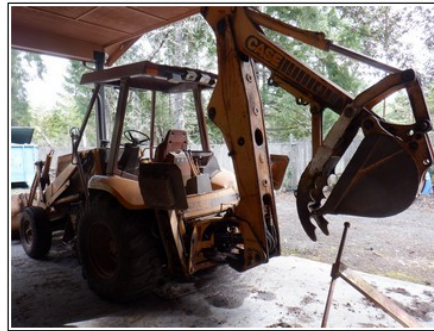
Case 580K. Age and condition unknown.

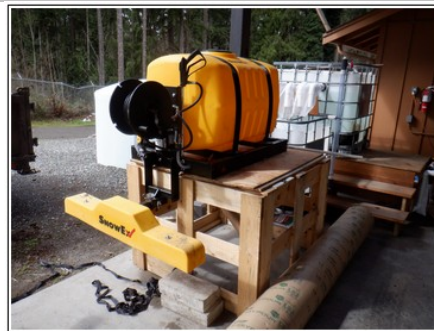
Makes salt brine, mixer machine

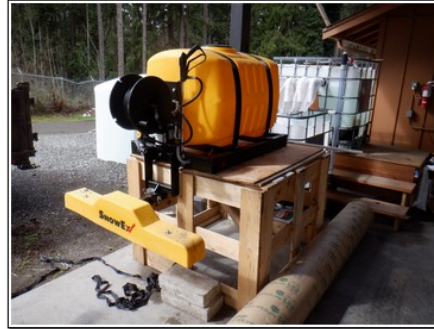
Sprayer for the machine - sprays brine down onto the roads to treat them.

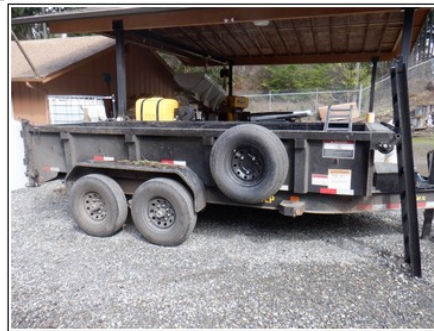
## Mechanical & Equipment - Maintenance Eqpt, Dump Trailer

Big Tex tandem axle. Length and capacity unknown.

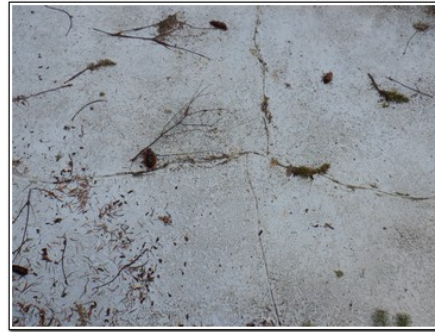
Planned for 2021. Coatings done in 2006, 2009, 2011 & 2015. Fair condition with no significant staining or deterioration observed. We recommend regular cleaning and proper balancing of chemicals/chemistry to maximize the life expectancy of the pool finish. The plaster may be wet polished between cycles of replaster.

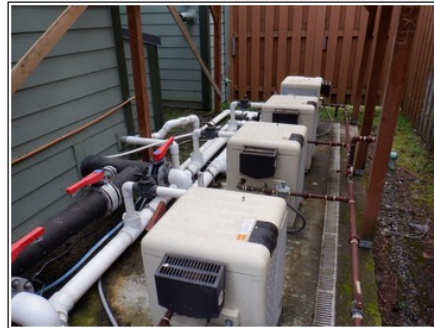
Replaced in 2015. Unknown condition of the pool heater. The life expectancy of these units are approximately 10 - 15 years. Master Temp 400.

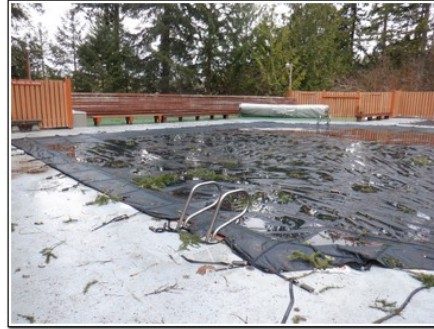
Installed in 2017. Generally good condition with no significant staining or deterioration observed.

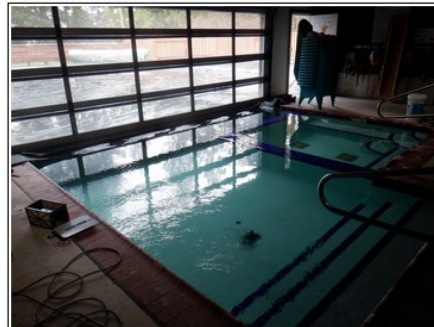
Resurfaced in 2015. Generally fair condition with no significant staining or deterioration observed. We recommend regular cleaning and proper balancing of Chemicals/chemistry to maximize the life expectancy of the pool finish. The plaster may be wet polished between cycles of replaster.

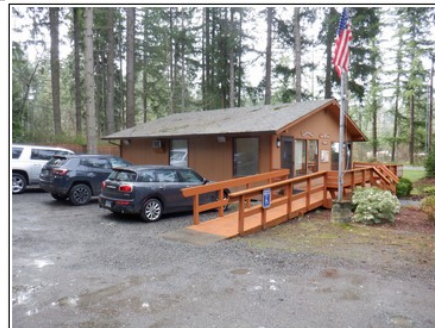
Planned replacement in 2021. Fair condition with no known or reported concerns at this time, such as water intrusion. We assume proper installation techniques and practices were used. Inspect regularly and repair as needed utilizing the general Operating Budget. The typical life expectancy is between 20 - 30 years for this type of roofing. We recommend that the Association should have a professional roof inspection performed by an independent, qualified Roofing Inspector registered with RCI not a roofing contractor.

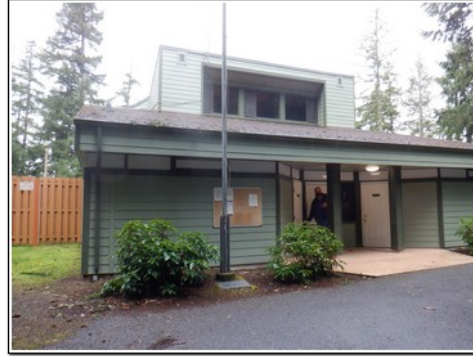
Replaced in 2007. Fair condition with no known or reported concerns at this time, such as water intrusion. We assume proper installation techniques and practices were used. Inspect regularly and repair as needed utilizing the general Operating Budget. The typical life expectancy is between 20 - 40 years for this type of roofing. There are no reported problems at this time, however, the Association should have funds set aside within the next few years should replacement need to occur. We recommend that the Association should have a professional roof inspection performed by an independent, qualified Roofing Inspector registered with RCI not a roofing contractor.
