CLEARWOOD COMMUNITY
BRIDGE & DOCK INSPECTION REPORTS
FOR
CLEARWOOD COMMUNITY ASSOCIATION
PROJECT #2020-0272

MC SQUARED, INC.

08 / 24 / 20

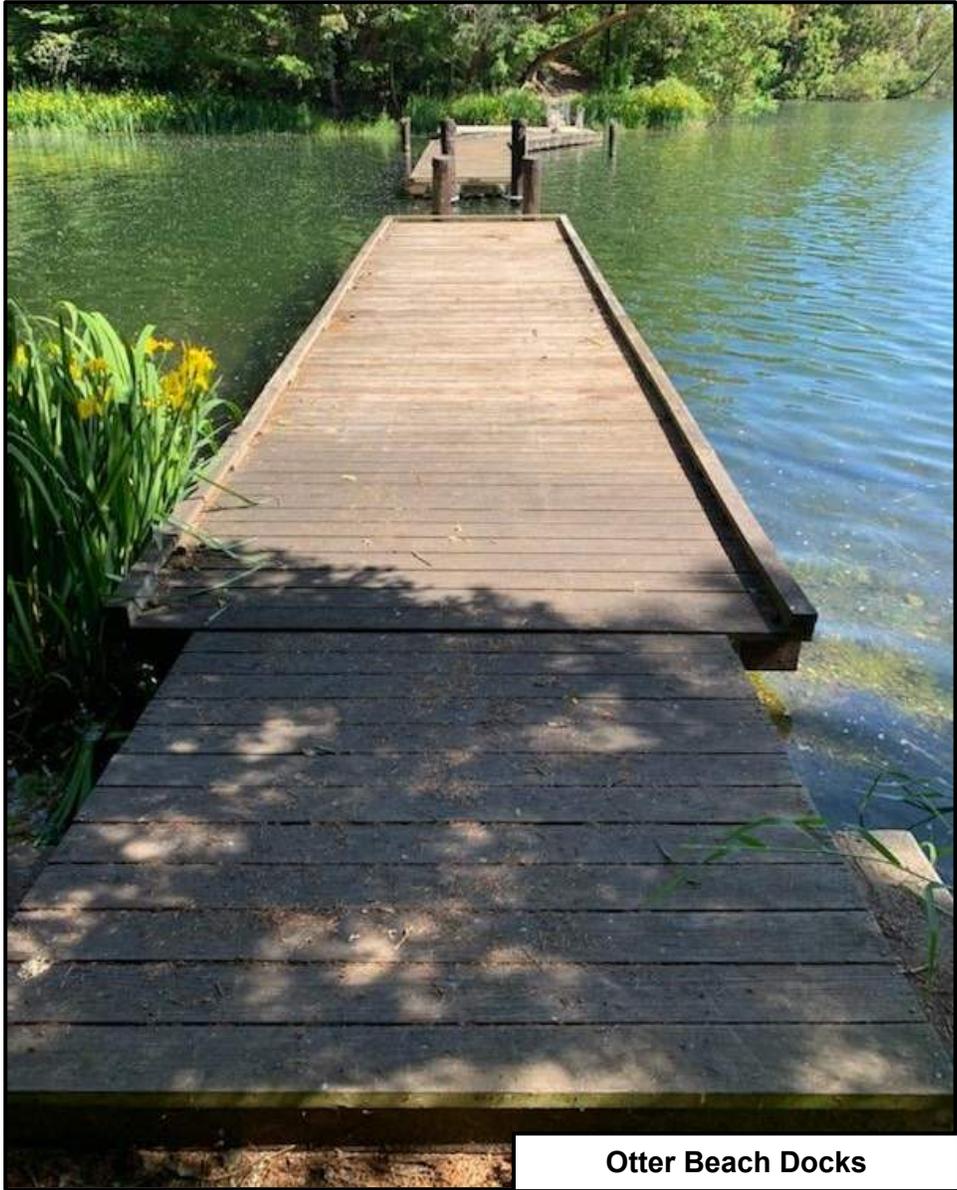
Otter Beach Docks

The pressure-treated framing is not experiencing significant rot or water damage, but up to 1/2" knife penetration was observed at some rim joist locations. This amount of penetration suggests that they may need to be replaced in the near future. Timber decking is experiencing surface weathering and is warped and lifting at some edges. The primary decking damage is located at the 20' by 14' section and is in need of replacement at the northern dock (Figure 1).

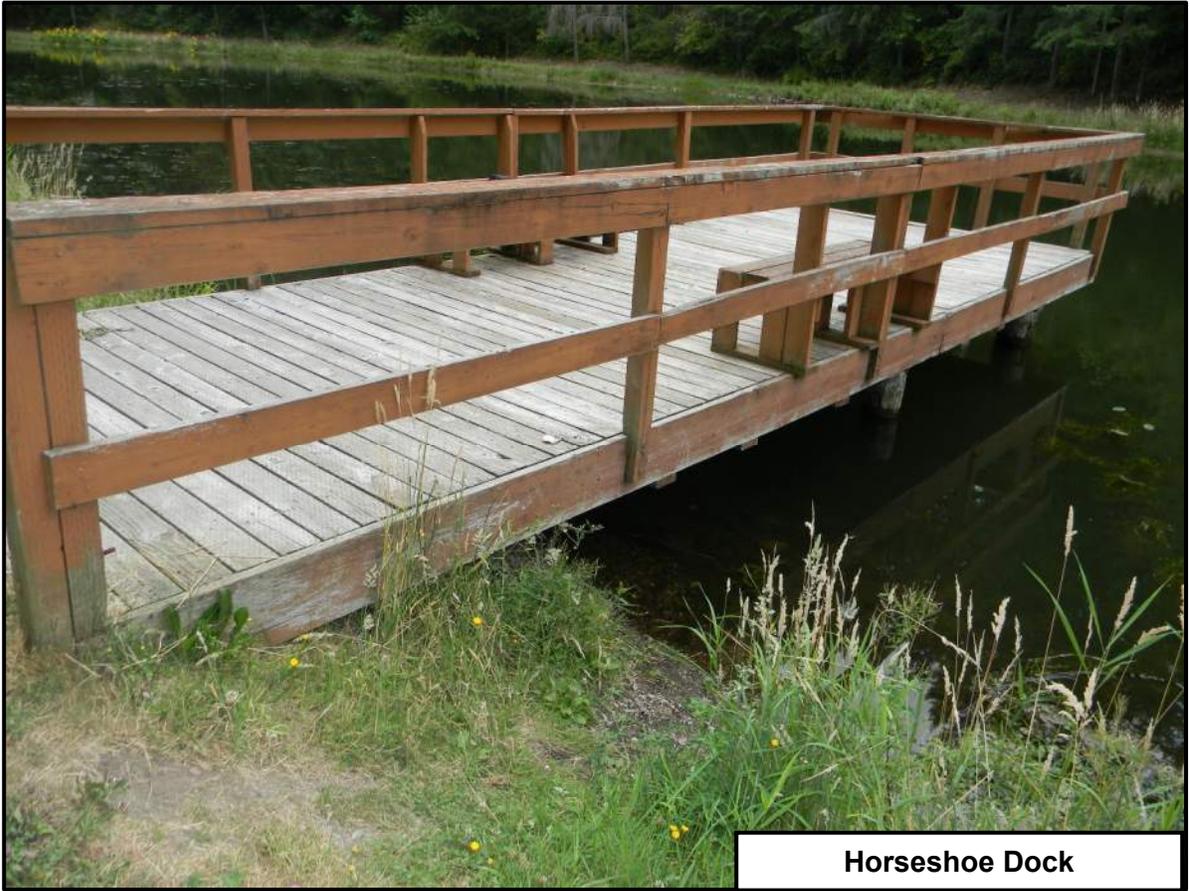
Horseshoe Dock

The rim joists are warping around the perimeter and are separating from the decking, causing nails to be exposed (Figure 6). The decking displays significant sagging and rot, which will require replacement throughout. Additional stringers are suggested to reduce this problem in the future.

Figure 6 – Decking Separation

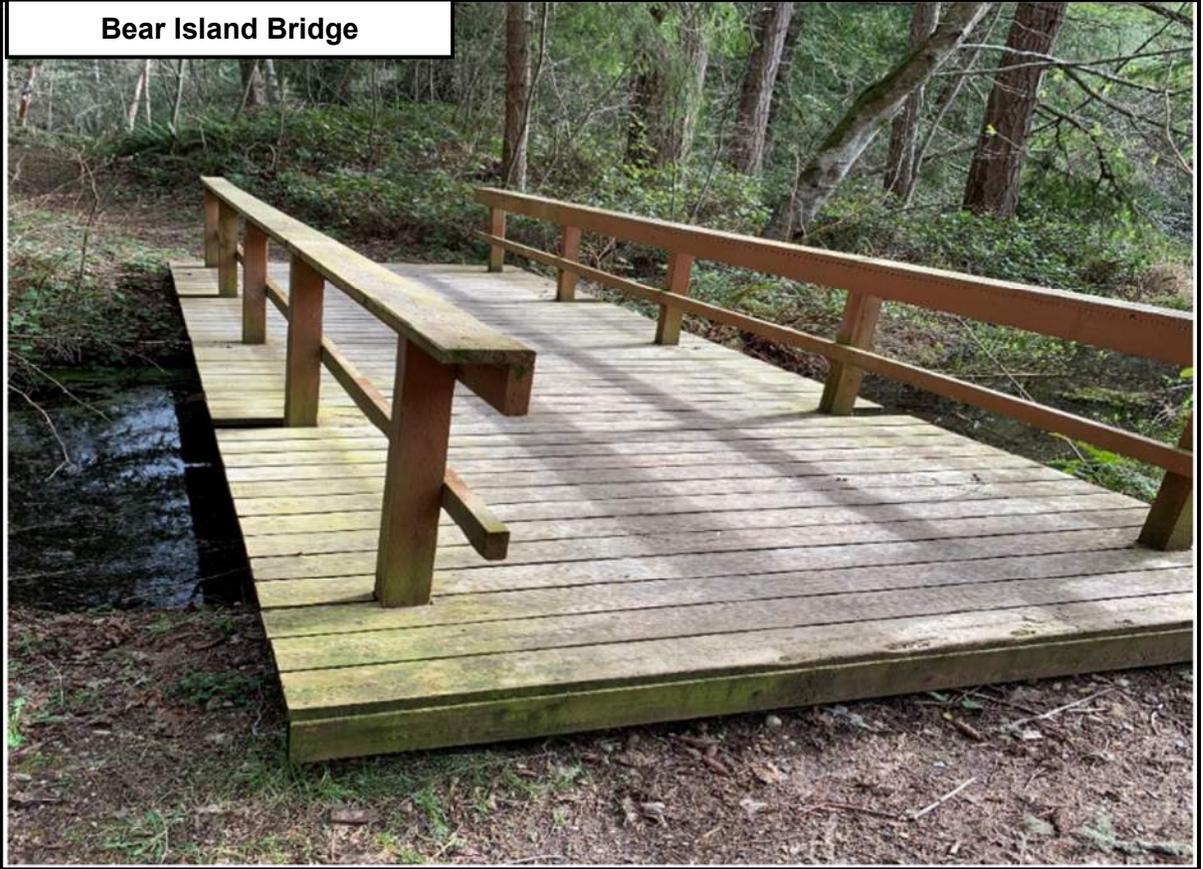
Bear Island Bridge

The guard rail posts are fully intact at the base and are attached to the exterior stringers with two 1/2" diameter bolts, spaced 6" apart. The posts are spaced at 6' on center and are deflecting when pushed on. Some of the guard rail posts are splitting or showing rot and should be replaced (Figure 8).

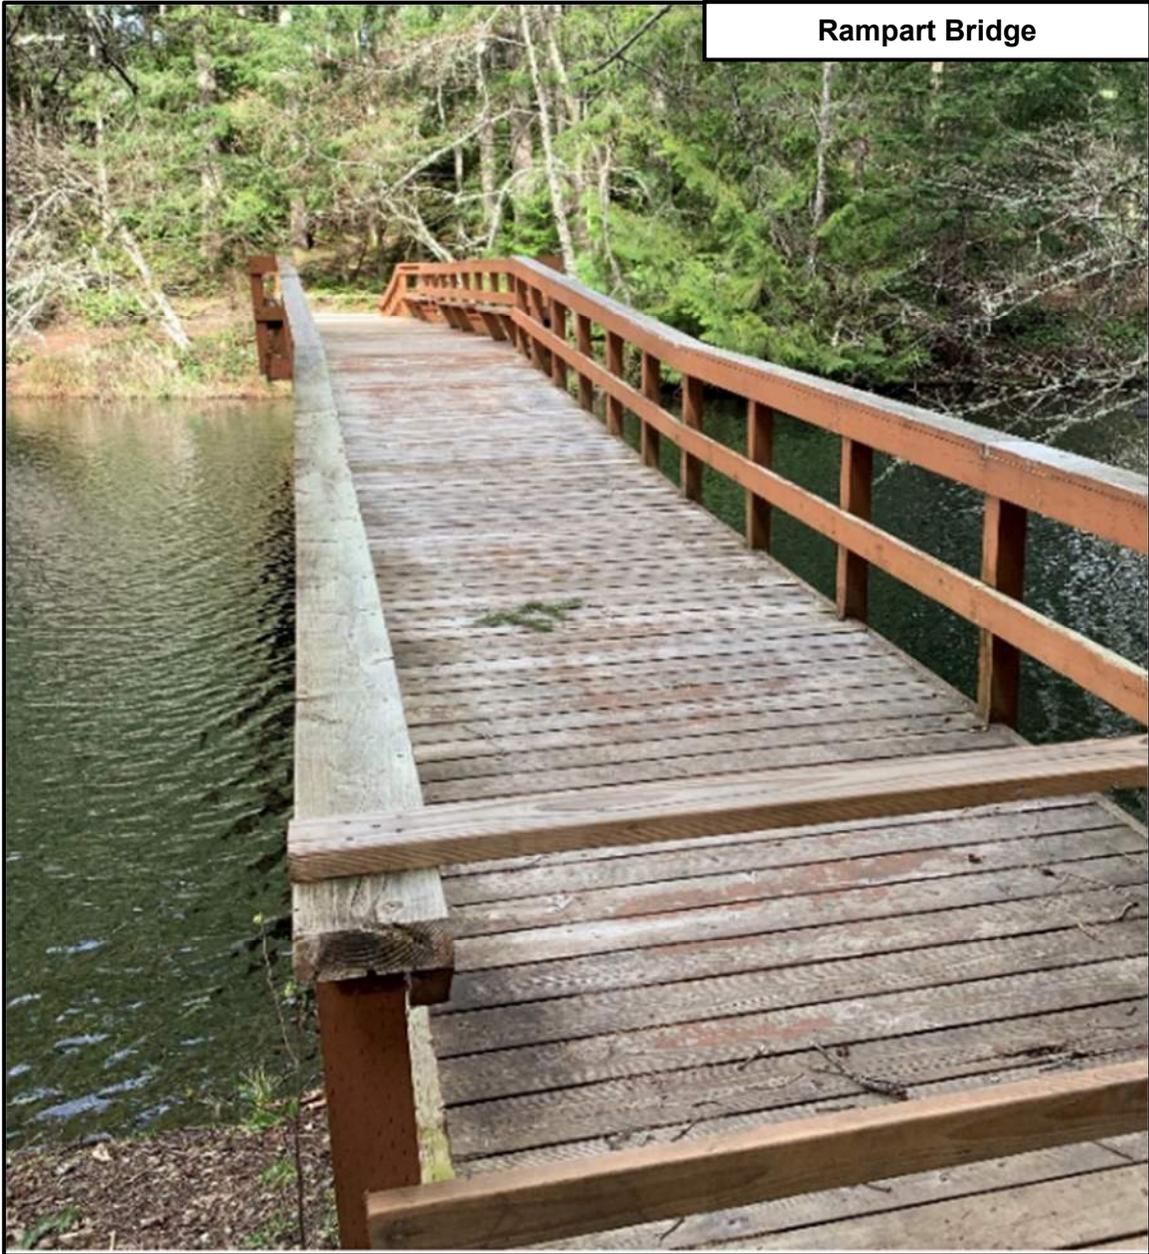
Rampart Bridge

All guard rail posts are attached to the rim joist/fascia, have been notched at the base, and are visibly sagging outward (Figure 9). The posts are also easily moved by hand. Many of the handrail sections are significantly damaged as well. The guard rails must be replaced with 4x6 or 4x4 posts without notching the bottoms of the posts and the handrails should be replaced.

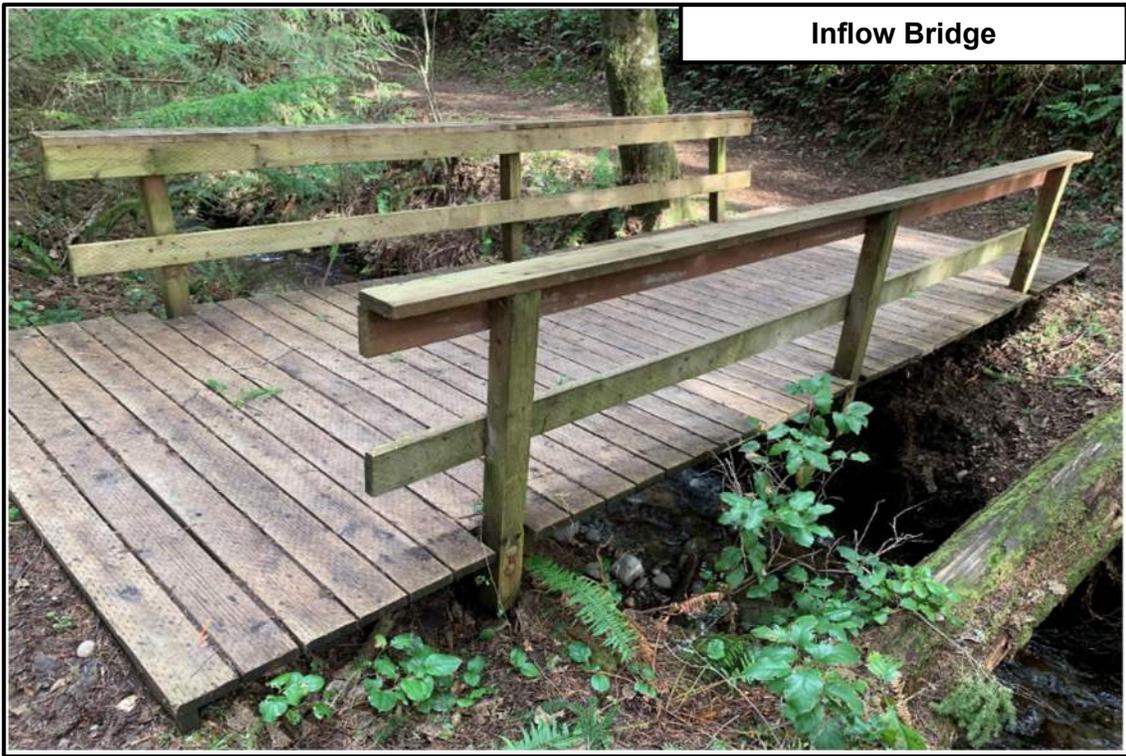
This bridge falls short of code requirements at almost every structural component of the bridge and should be replaced. The bridge currently will not fall down with one or two people on it, but it is still a safety concern.

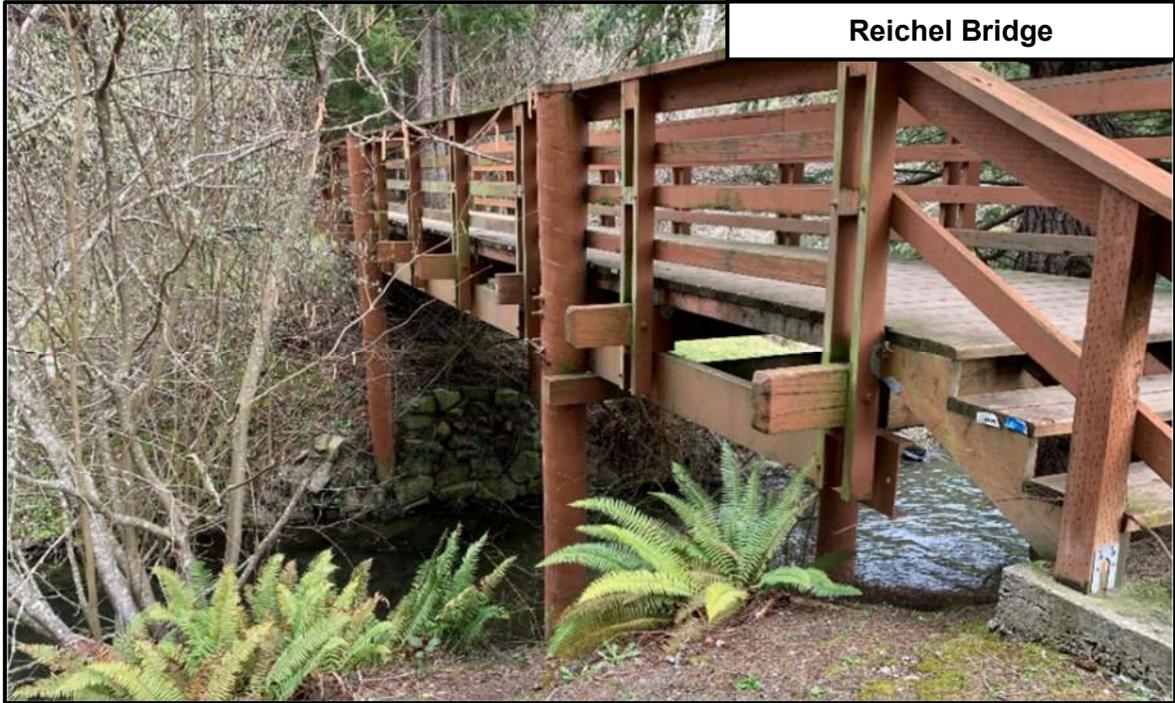
Reichel Bridge

The steel channels are to be free of rust and the exterior paint coat is undamaged. The 4x8 beams supporting the stringers are also supporting the guard rails at their ends and extend out up to 2' at some locations. The extended ends are deteriorated at some locations and should be cut off and sealed with a cap (Figure 12).
